Repairing a Damaged Nose Cone (also referred to as Front Cover). The tip relates to RN, RP and later cars - by Ron Hayhurst

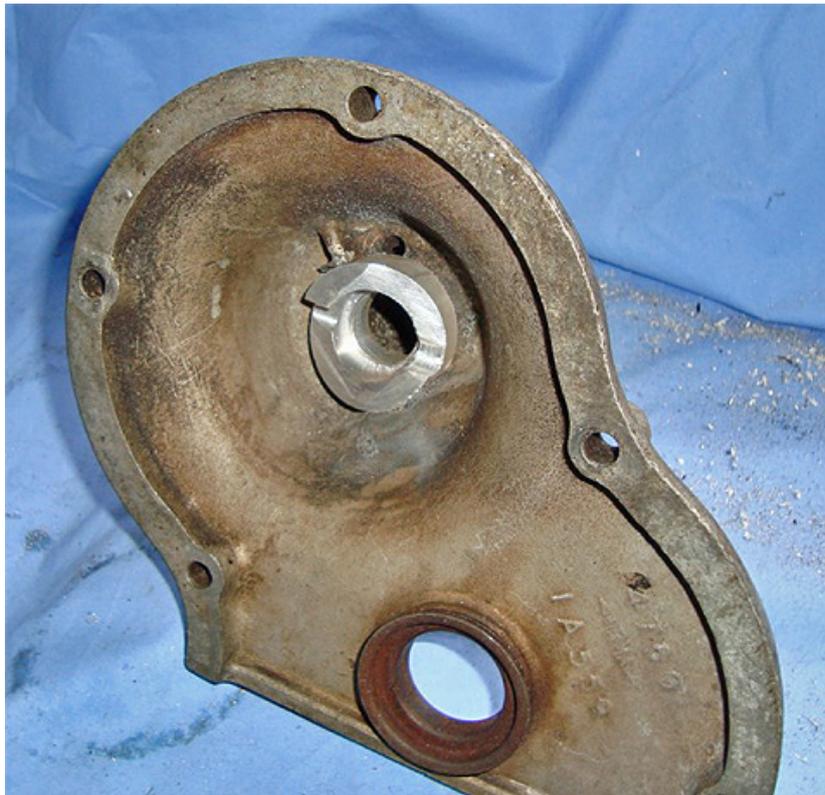
Replacement nose cones in good condition are becoming harder to source. If the starting handle dangles rather than latching in a horizontal position as intended, the fault lies in the wear/breakage of part of the casting inside the nose cone together with a badly worn pin that engages with the crankshaft when using the starting handle. The required profile can be reestablished by machining out the damaged part and shrinking in an insert with the required profile. A new pin should use a high tensile steel such as is found in a big-end bolt. Knock out the old pin noting the groove in the middle. File a similar small groove on one side of the replacement pin, apply Loctite 270 (Studlock) and thump the depression seen at the end of the shaft down into the groove in the pin. Machining inside the nose cone just isn't possible without some kind of jig and making up an insert with the correct profile is best done on a milling machine. The depth machined into the cone and the length of the new insert needs to be carefully dimensioned. There is very little distance between the pin on the starting handle shaft and the dog on the crankshaft when rotating the starting handle backwards (e.g. for the next attempt at cranking). I was very pleased to get Malcolm Watts to do the machining for me. He made an excellent job. Apart from looking better with a latched up handle, a new pin nesting in a new insert should greatly help to reduce the loss of oil along the starting handle.

New insert

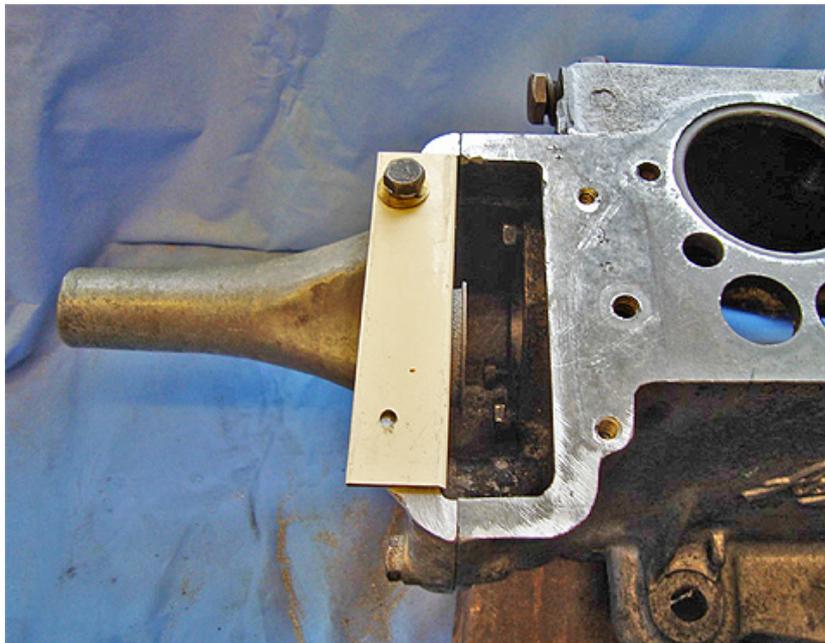
Now the other more "terminal" damage that can be inflicted on a nose cone is to have one of the lugs that secures the dynamo housing shear off. I was lucky enough to get a skilled welder to build up the missing area ready for drilling and tapping. It is obvious that the new hole has to be in exactly the right place so I was left with the problem of making a suitable jig and then securing the awkward shape of the nose cone prior to doing any drilling. As you will see in the picture, bolting it to an empty crankcase turned out to be the answer. To make the simple jig I located a strip of steel from an old drawer runner that had a turned over edge about 3mm deep. The strip was cut to the exact length that would allow it to sit inside the rear edge of the nose cone.

With the turned over edge pulled tight against the rear edge of the nose cone the location of the remaining good hole was carefully transferred to the strip and a  $1\frac{5}{64}$ " hole drilled. This was reamed to  $\frac{1}{4}$ " diameter. With the strip bolted to the nose cone the location of the "missing" hole was determined and centre popped prior to drilling  $1\frac{1}{64}$ ". Although the tapping size for  $\frac{1}{4}$ "BSW is  $\frac{3}{16}$ " I decided to leave a little metal in case the new hole in the welded up lug needed

Drilling out the lug still posed a bit of a problem as I wasn't confident that working on my own I would be able to drill square on to the cone. Fortunately I was able to dig out a frame which hadn't seen daylight for more years than I care to remember and was able to mount the drill and chuck into it. With the jig bolted on to the good hole I was then able to fit a G clamp to the frame and made the 11/64" hole. The crankcase continued in use as I tapped the new hole 1/4"BSW.

Finally I dug out a couple of long high tensile bolts with a 1/4" BSF thread on them and cut them down to make a couple of studs; the new threads being made 1/4"BSW. These were then installed in the repaired nose cone again using Loctite 270.
