Gas and Ignition plate - advance and retard plates - (Control Bracket)
- Ian Moorcraft

ADDENDUM on Gas and Ignition Plate (Control Bracket)

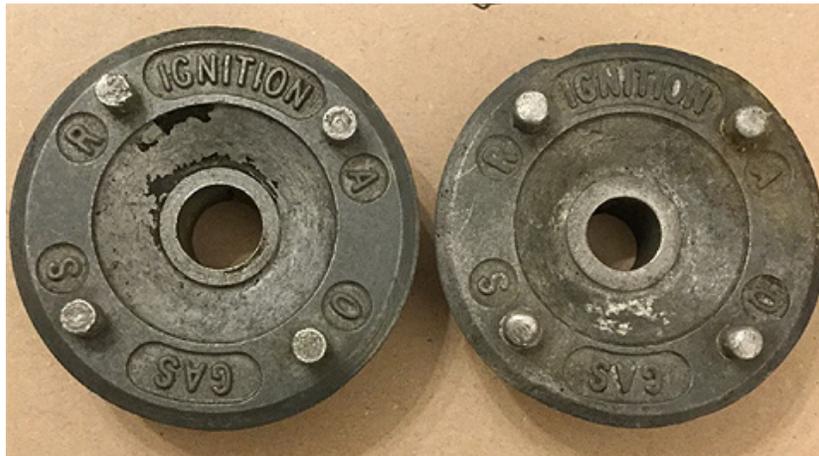
I have two originals with 5/8" holes part no. XL988 and the other 1A 6051. I also have a 9/16" hole one with the same part no 1A 6051 (the pair in the photo).

I found out the answer a while ago when I noticed a bush BM40 'thin copper' listed with the control tube in one of my illustrated parts list. I immediately realised why I have seen so many broken control brackets that have been over tightened and why so many cars have them revolving with the levers obviously missing that crucial bush (probably a split bush). This bush is first listed in parts list 353f for 1925 but the control bracket part number BM6 is the same as the earlier cars that don't have the bush listed, but looking at my XL one that has a 5/8" hole I guess they also used the bush.

I am of the opinion that the control brackets were changed to 9/16" holes in 1929 when the new part number BM128 was announced, and the bush discontinued. The lists seem not to have been updated as most originals you find have 9/16" holes.

The moral of the story if you are lucky enough to find an original bracket check before you fit as the control tubes are always 9/16" diameter.

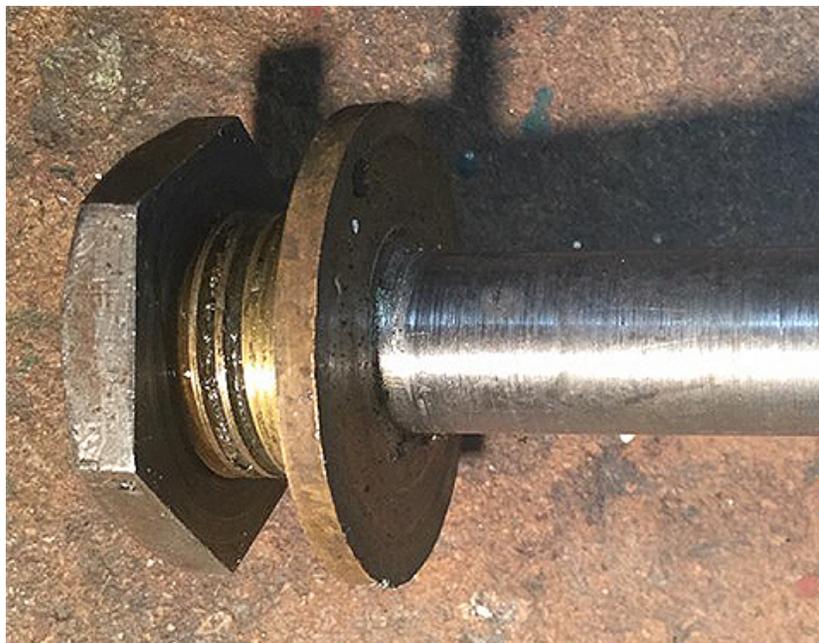
Picture 1

Picture (1) shows the brass socket that is soft soldered on to the steering box end of the control tube. This assembly is the first thing that is fitted when building up the box. It was fitted at the factory and staked with four deep punch marks to keep it in place picture (2). It should never need removing for the life of the box. The box can be completely stripped and rebuilt with the control tube and socket still in place.

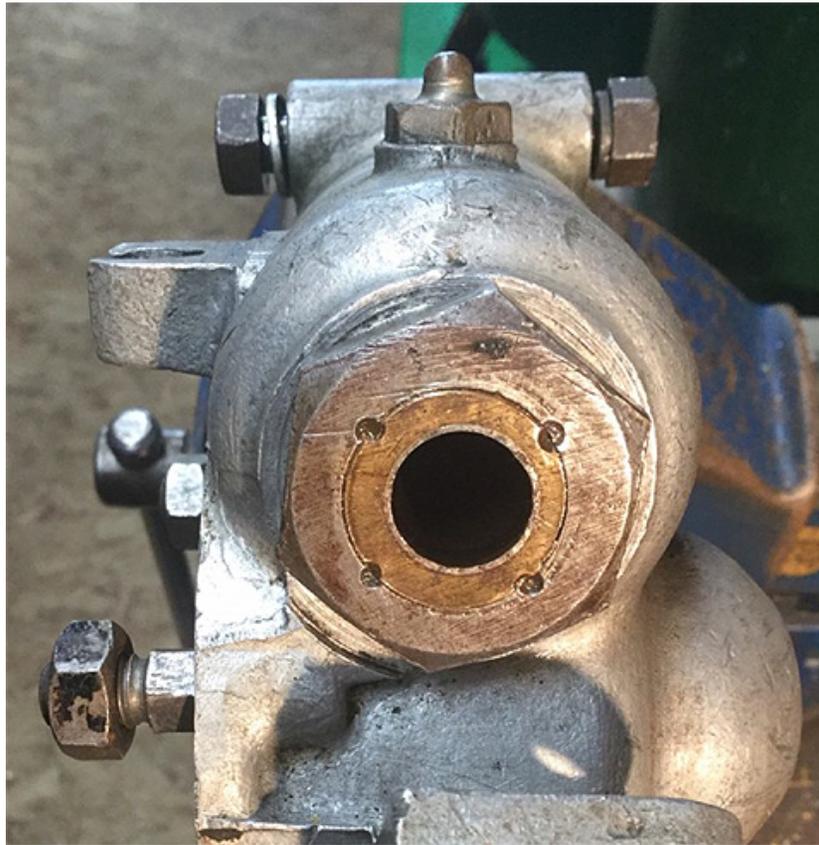
Picture 2

These punch marks are where the problem begins when someone tries to remove the nut for reasons known only to them. The nut jams on the punch marks and the socket rotates and will not tighten back up.

The safest way to proceed without causing further problems is to release the outer steering column from the dashboard clip, loosen the 5/16" pinch bolt on the top of the steering box itself. There is a 1/4" locking peg bolt that picks up in one of the castellations in the outer column socket to lock the adjustment.

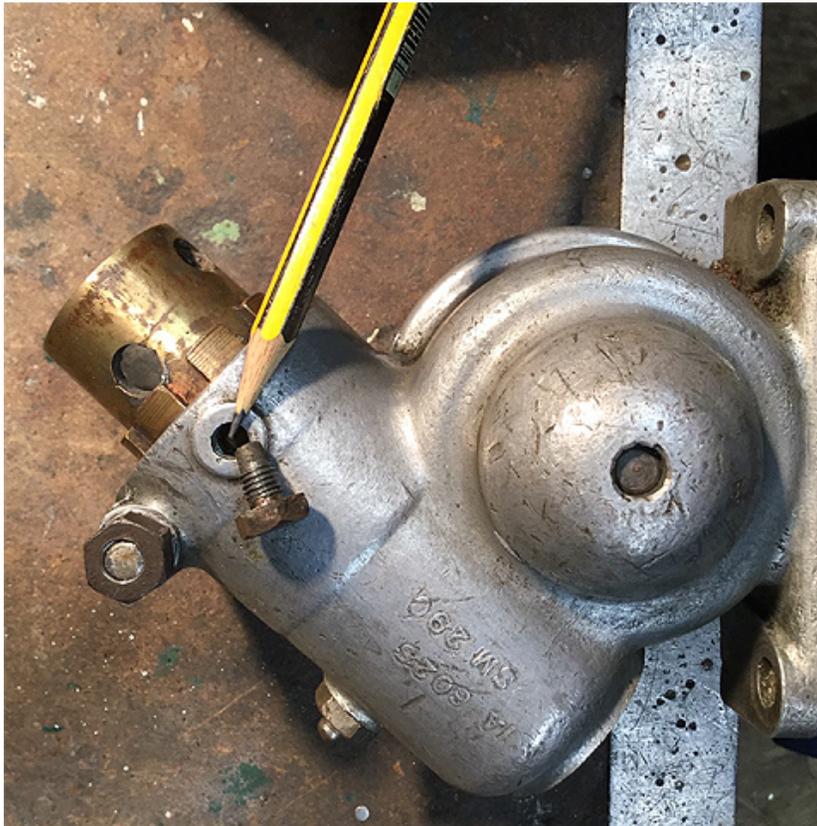
Picture 3

It's shown in picture (3). Remove it (not easy with the box in the car!) Mark the position of the outer column in relation to the steering box casing. Using your toolkit 'C' spanner tighten down the outer column as far as it will go (this should only be a couple of castellations at most).

The loose socket will be locked tight inside the box and you should then be able to tighten the large nut at the bottom of the box. Loosen the outer column until your marks line up then check for up and down play in the steering wheel.

If you do have some play tighten down the column a little without creating any stiffness when the steering wheel is turned lock to lock, refit the locking peg bolt. Note: later boxes other than the early one shown have two holes side by side for a finer adjustment of the locking peg bolt so choose the best position to suit your adjustment (it's even harder putting the peg bolt back than removing it!) refit the dashboard clip.
