### Engine - three bearing - oil feed - by Ron Hayhurst

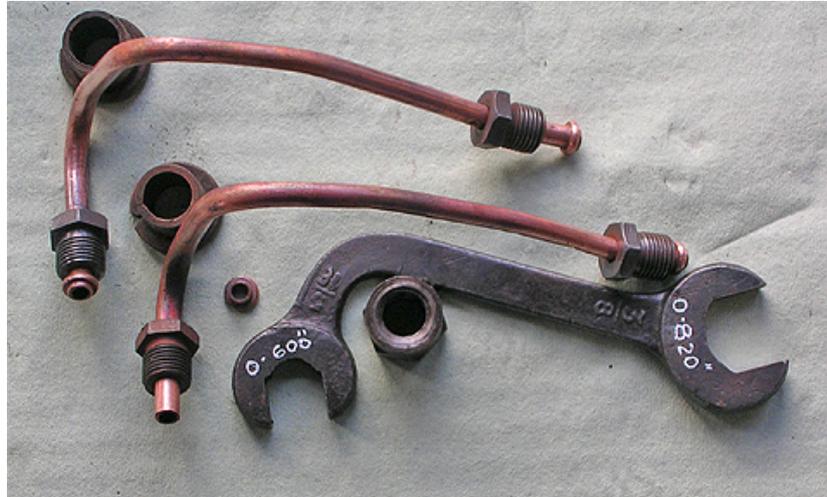
Removing the pipe from the crankcase is not straightforward unless you have a cranked spanner. The picture shows "the one I made earlier". An old spanner was taken to red head and whacked around to the shape shown. Then with an angle grinder and finally with a file the jaws were made 0.820" and 0.600" wide. The larger size jaw is to undo the threaded union (also shown in the picture) which is

at the feed end of the pipe. This needs to be undone at the same time as slackening off the back nuts. It is worth noting that the removal of this pipe is one of the earlier tasks when you are stripping the bottom end of a three bearing engine, so such a spanner is an important part of your kit. As an aside, do not attempt in an engine strip-down, to remove the banjo bolt (the one hidden behind the flywheel) and to which this union is bolted, without removing the union first.

The picture also shows a couple of spring bushes. These are there just to prop up the pipe to show the best angle.
