Rotor arms - Bosch - by Terry Griffin

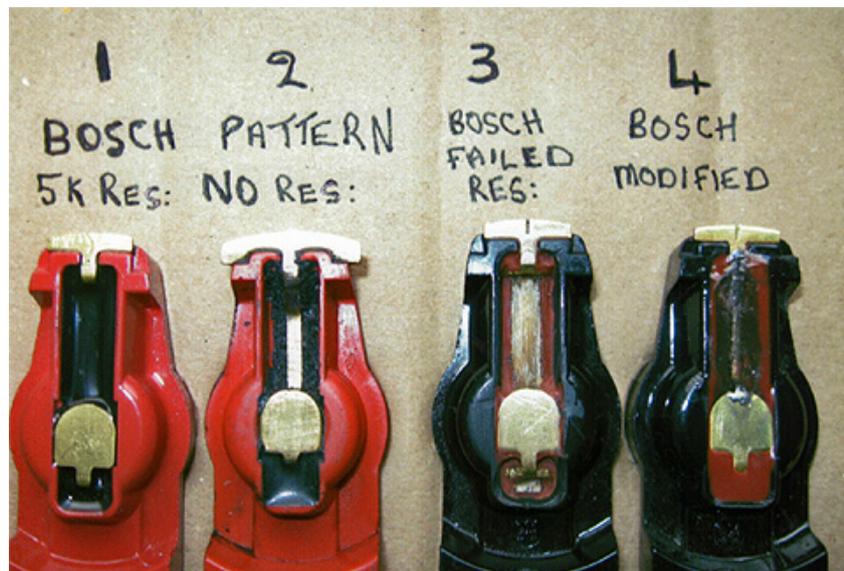
Original Bosch rotor arms are fitted with 5000 ohm/5K resistor which can fail, resulting in no sparks. Unfortunately, you cannot test it without an ohms meter or multimeter. If you try to do a continuity check with a test lamp, it will not light as the resistor will not pass the current, even if the rotor arm is OK.

In the photo of the four rotor arms, No2 has a continuous brass strip between the centre brush contact and rotor contact so we do not have a problem with this one. I have removed the insulation to show this, as it looks the same as No1. On the No3 arm, the resistor has failed, so there is no connection between the contacts – the insulation is removed to show the resistor. No4 has been modified to overcome this problem.
