#### Crankcase - cure for a broken foot - Dan Cole

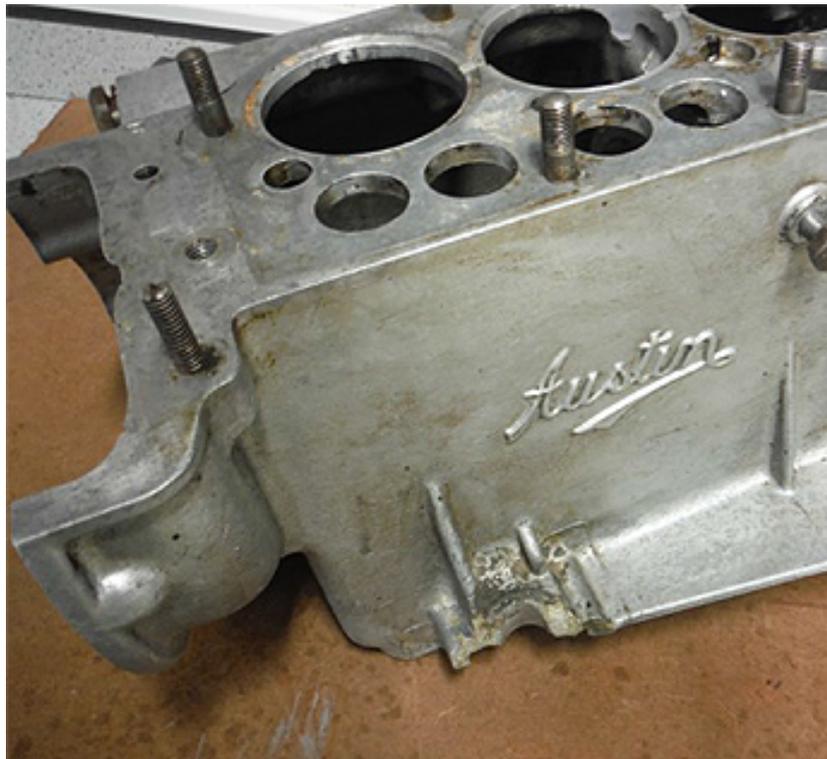
I acquired a spare engine a few years back which was generally good except that one of the mounting 'feet' was unfortunately broken off roughly through the centre line of the hole.

ooooouch !

I have seen this problem on a few examples over the years. In the case of solid mounted engines, if the engine is bolted down tight on all four corners the feet

can break under racing conditions due to chassis twist. With my example, a three bearing rubber-mounted type, it was most likely that it had simply been dropped at some point. The engine could have been used as it was but it would have looked a bit unsightly and, when I realised it needed some internal attention which required complete dismantling, I got stuck in and tackled the repair. If you need to carry out a similar repair this might be of interest.

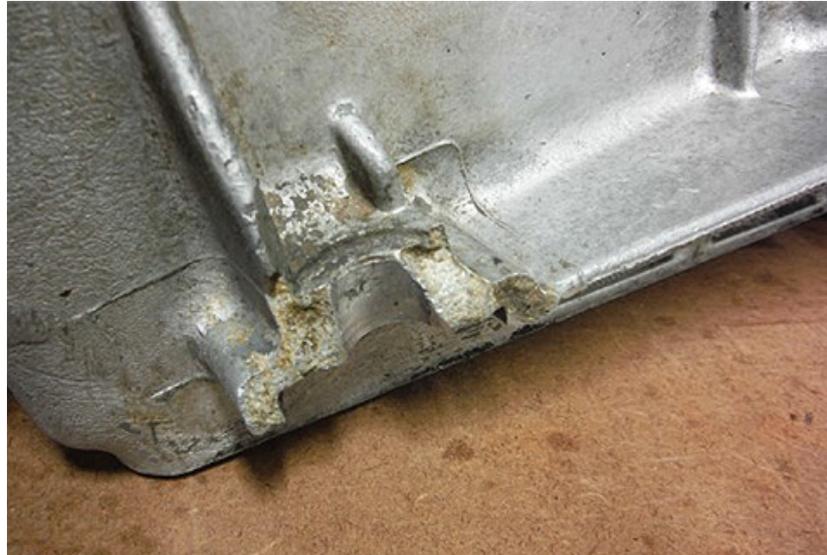
ooooouch - in detail !

Crankcase repairs like this can be done by gradually building up the area by aluminium welding before fettling it back to somewhere close to the original shape. Since quite a chunk of material was missing I elected to make up a repair section to weld in. Firstly I took some careful measurements and produced a sketch showing the detail of the foot cross section. Some lathe tools were then ground to match the internal and external radii required. An off-cut of aluminium bar was found and I set-to with the lathe.

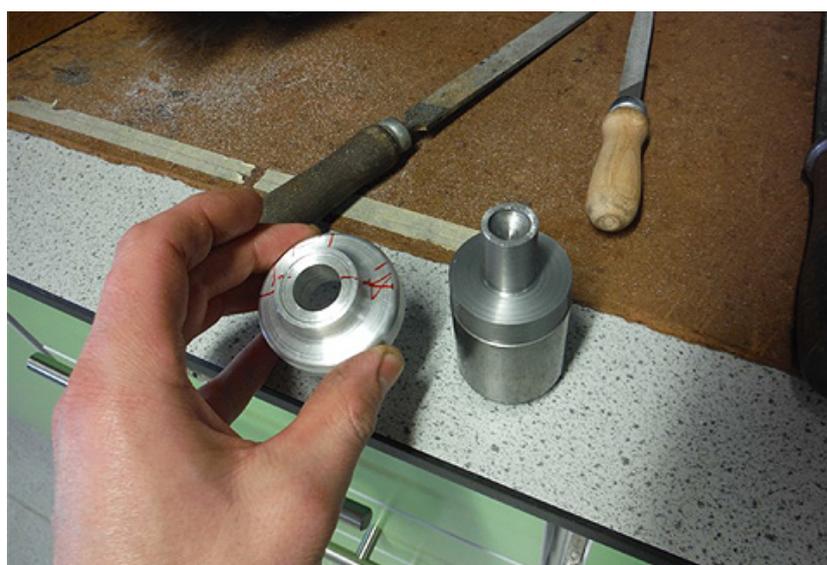
Turned part ready to cut (with steel alignment too on bench)

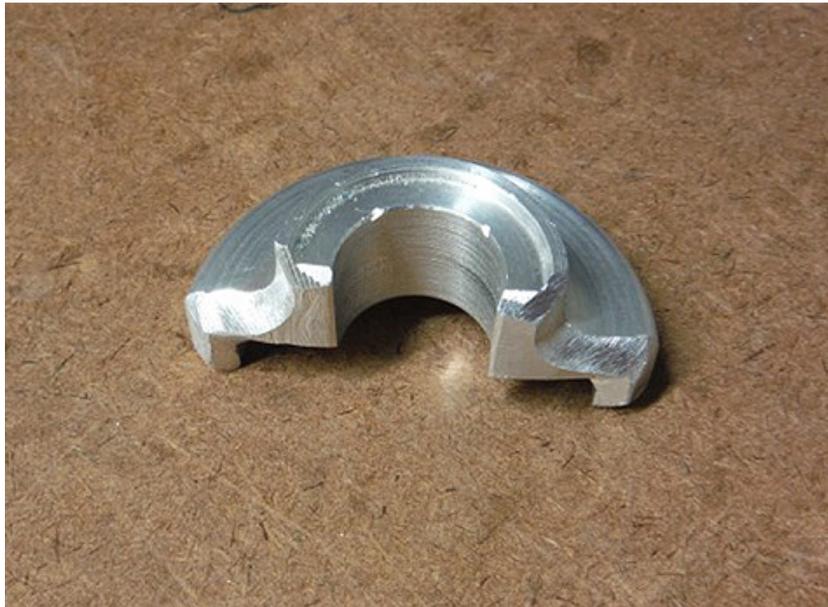
Repair section, cut, chamfered and ready to weld

Once the part was machined to match the original foot profile as closely as possible I cleaned up the broken crankcase edges to get back to clean metal (very important with aluminium welding especially with old castings). The repair piece was then marked up so it could be cut roughly in half in the appropriate place. When pairing up the original cast crankcase and the newly turned repair section it is difficult to achieve a perfect location. To aid the lining up process a simple guide fixture was turned up from scrap steel bar (this located through the hole and in the pocket on the underside of the foot where the rubber fitting usually goes). All edges that were to be welded were chamfered. After a final thorough clean of both parts with a stainless steel wire brush the repair piece was united with the crankcase and welded into place after being securely tacked.

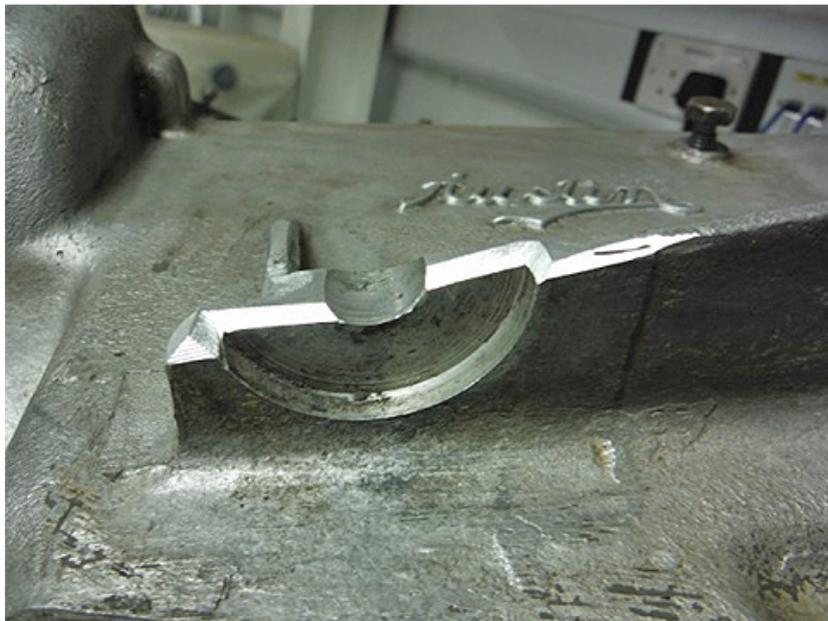
Crankcase prepared for welding

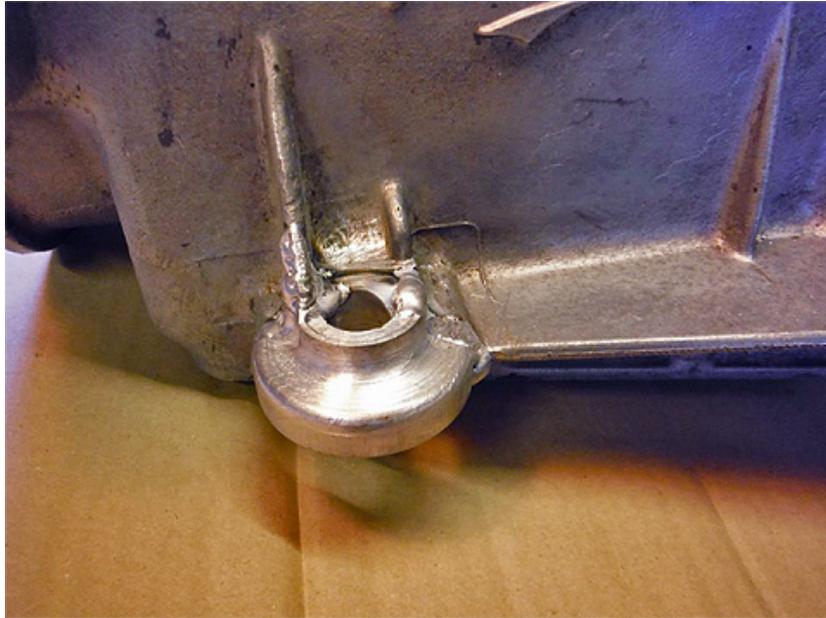
Finished article before filing to clean up welds

I don't have my own aluminium welding kit so the welding was generously carried out by a friend who made a really nice job of it. Because of the complex original shape there was still a little 'building up' required to blend the turned part into the crankcase. Overall I was pleased with how the repair turned out, I still need to do some filing to tidy it up but it has done the job.
