### Starter motor switch - Lucas S2 - Ian Moorcraft

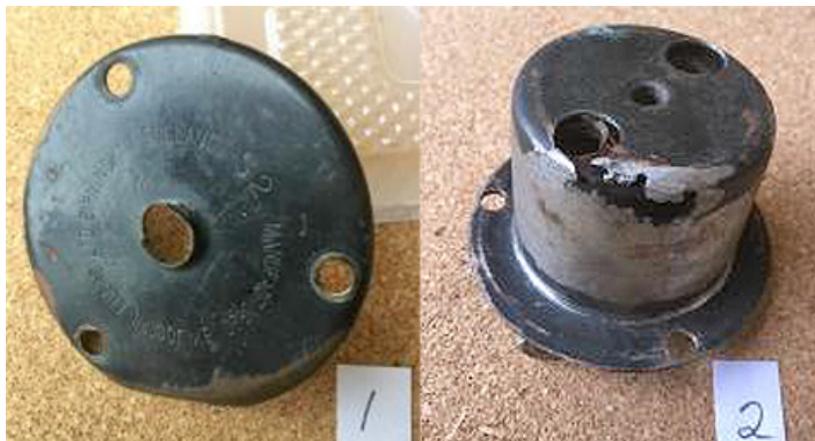
There were three different versions of starter switch fitted to the “bacon slicer” cars. The first Sevens with electric start had a CAV switch followed by a Lucas S2 late in 1926, the S2 was improved for the 1929 season to design out inherent problems mostly with the insulation. Also the brass cover plate was changed to steel and the button was now cast iron with a cross hatch pattern for grip.

It's the middle one with the Bakelite button we are looking at here marked S2 that has the issues.

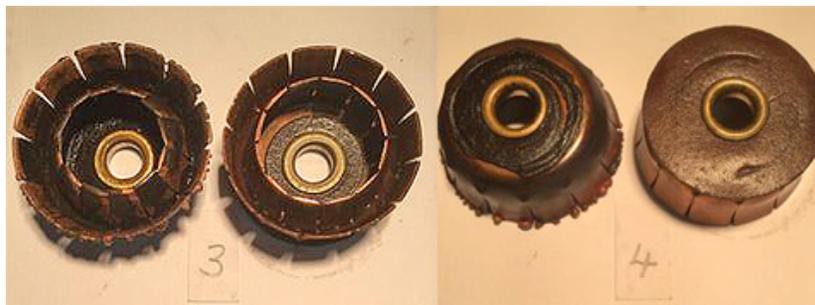
The main issue to look for is the thin brass switch cover plate wears (pic1) this results in the copper contacts of the switch not meeting squarely. The switch button copper contact becomes damaged giving a poor electrical connection with possible overheating or even a short circuit. Picture 2 shows one that has had this event and melted a hole in the steel switch body !

With the switch removed it's a simple matter to bend back the tags from the rear of the three brass eyelets, don't try to drill them out as they will only lock on the drill and spin. With the cover removed, it will become obvious how simple the switch is and how the copper contacts can be bent if not presented squarely to each other. Pictures 3&4 show two switch button contacts, the one on the left is from the worn switch in picture 2 above, notice how the inner ring has overlapping segments much like fish scales, while the outer ring has spread to a larger diameter as the segments flattened. Also note the ends of the outer copper segments have melted. The contact on the right from another switch is how a serviceable one will look with no overlapping or deformed contacts.

Disconnect the battery, remove the two bolts that hold the bacon slicer, be aware that a small locating dowel (part no. BG55) is next to the off side bolt, this can, if loose in the crankcase drop into the bell housing as the bacon slicer is lifted off it. If not noticed can result in locking the flywheel and seizing the engine.

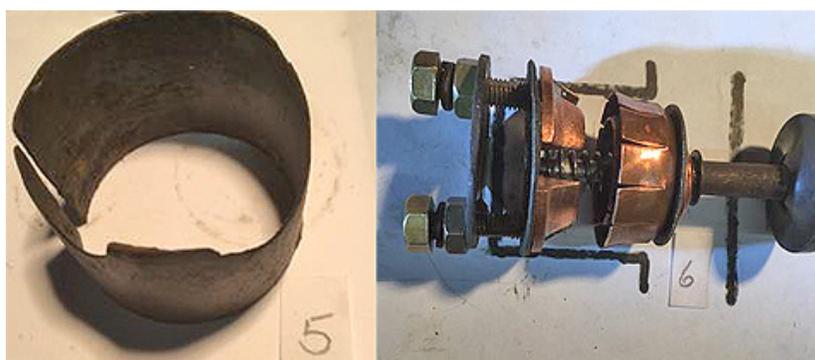
Clean everything up and inspect, probability is the tubular insulating strip (pic 5) will be broken or burnt near the bottom like this one, and needs to be replaced. This is the major cause of a short circuit allowing the half round contacts which must be insulated from the switch body to touch, resulting in picture 2.

Remove the double nuts, flat and spring washers and outside insulation washer. Tap out the two half round triangular copper contacts, carefully remove the thin insulating strip wound inside the switch body sides which is .023 thick followed by the insulator in the bottom of the switch body.

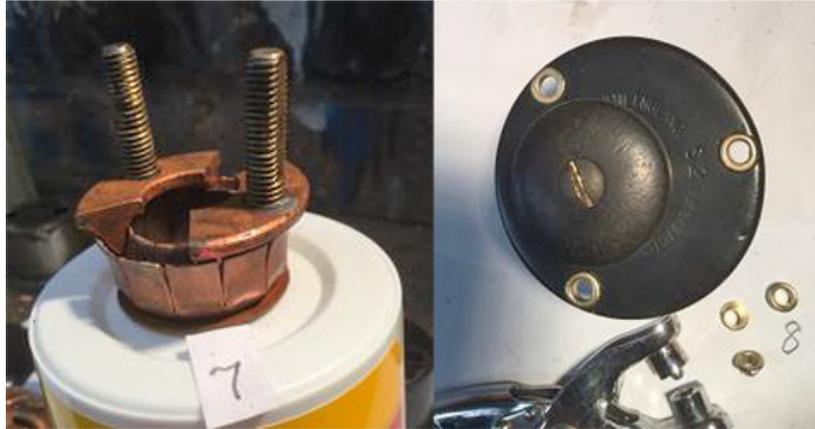
If your switch contact is like the one on the right of pic3 leave as an assembly on the button shaft and give it a good clean to bright copper. If it's badly out of

The left hand contact in my pictures has been so hot it melted, copper melts at 1084°C and is now too soft to be any use other than to flatten it out for a pattern to make a new one. No spare contacts are available as far as I know. The worn switch cover can be recovered by soldering a flat washer inside to cover the elongated hole.

shape like the one on the left, I suggest you remove it from the shaft by removing the split pin and screw it to a solid piece of wood held in your vice. Draw a circle of 1 3/8" from the screw centre on the wood, and use as big a flat washer as you can get in under the screw head to stop distortion. You will need to re-form the fingers as best you can to an outside diameter of the outer ring to 1 3/8" (in line with your diameter mark on the wood) the hole in the inner ring of fingers should be about 7/8" after readjusting. Suggest using a punch instead of pointy nose plies as the fingers are fairly stiff. See what your fit is like using the half round bottom triangular contacts as a guide, making sure that the fingers don't bottom on the ridge of the triangle Pic 7.
