### Engine cooling system - water branch - blockage problem - Jim Blacklock

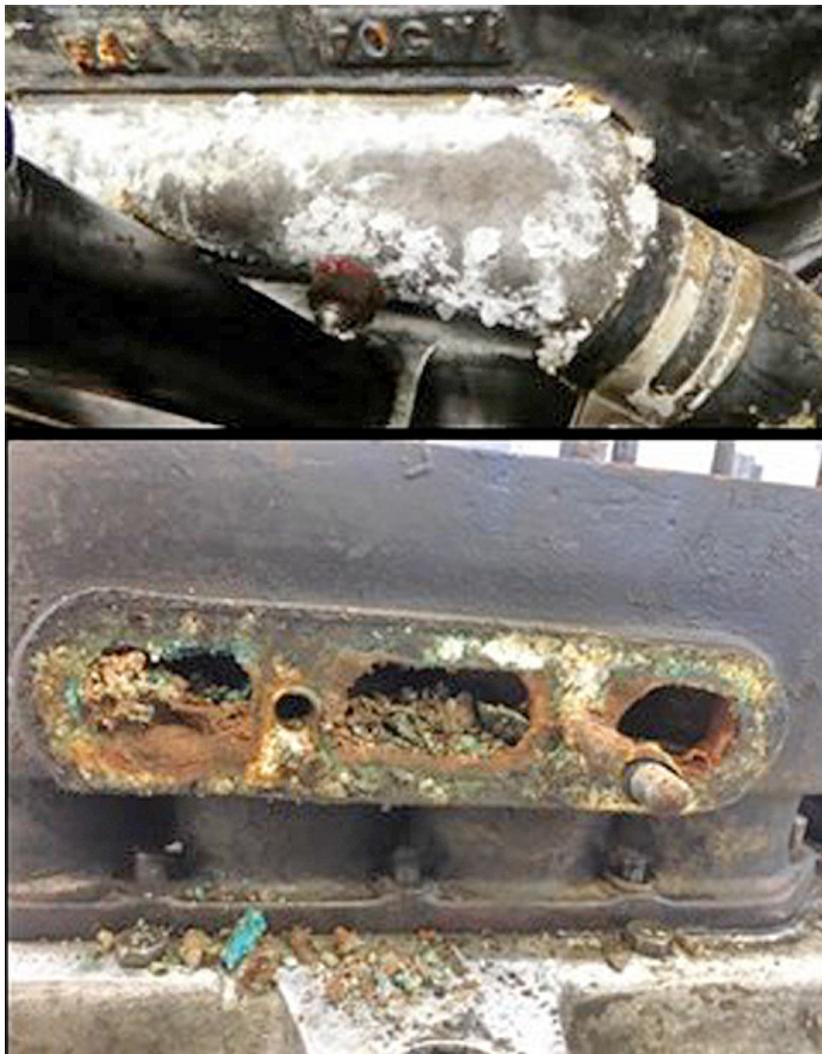
In the Austin 7 engine cooling system, this same situation has been created, in that we have the aluminium water inlet and outlet branches (anodes) bolted to the side of the cast iron engine block and the cast iron cylinder head (cathodes), plus the water in the cooling jacket (which acts as a simple electrolyte solution,

bearing in mind that even rain water these days tends to be acidic), so we have a simple electric cell. Again the white insoluble aluminium oxide is formed in the engine cooling system water, but as there is no way of flushing it away (because the Austin 7 cooling system works on the thermo-siphon cycle – i.e. there is no water pump), so it builds up over time in the engine water jacket and clogs it up. At the same time, the inside surfaces of the water branches corrode away. (Here are a couple of photos of an example engine, which were taken in October 2020 – in the upper photo you can see that the side inlet water branch was so badly affected by aluminium oxidisation, which has eaten its way through to the outer surface and it just crumbled away as it was removed! The lower photo shows the build-up of aluminium oxide powder, in the cylinder block water jacket, stained with rust and antifreeze.) Thus we end up with overheating Austin 7 engines, which will have to be stripped down, the aluminium oxide powder removed chemically (such as by a hot caustic acid bath, as mentioned in the Austin 7 article in the December 2020 issue of Practical Classics), and the engine rebuilt with new water branches and all the other costs and time that are involved.

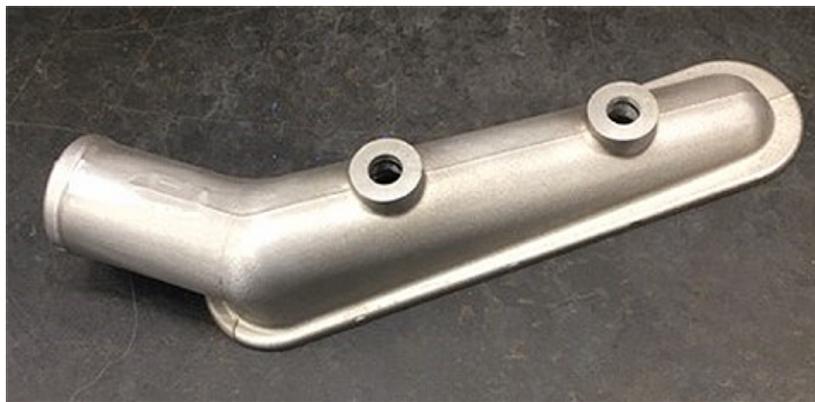
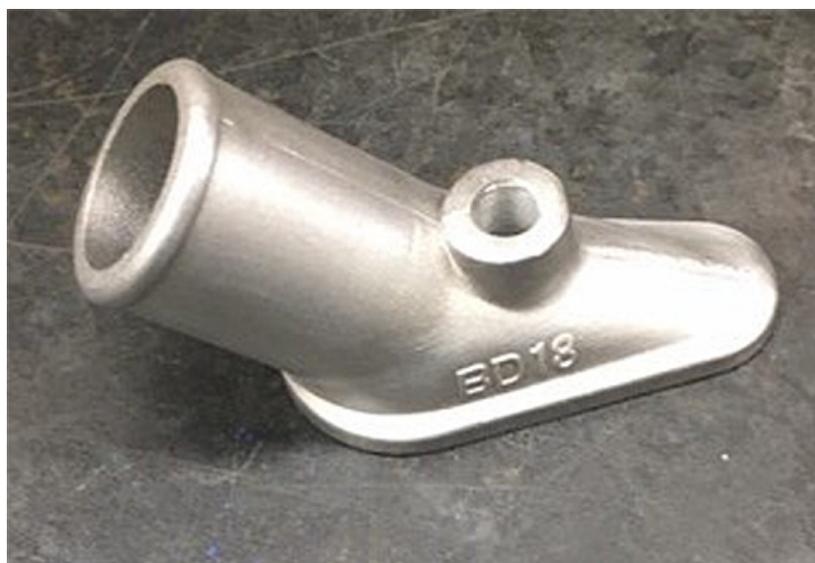
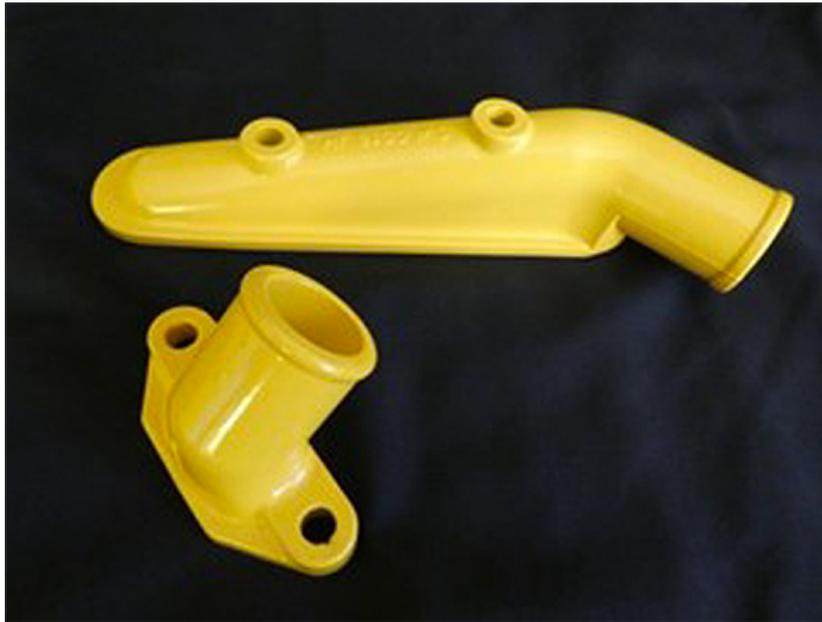
Ian and Oxfordshire Sevens is now producing kits of powder coated water branches, in a matt aluminium colour, as shown in these photos, (though you can order them in any colour you want – for instance yellow!!!!!!).

For the earlier engine (1923-36) it is the JBIT-001 Kit

For the later engine (1936-39) it is the JBIT-002 Kit.

But when I was discussing my thinking about this problem with Ian Tillman, of Oxfordshire Sevens, he immediately suggested using powder coating on the aluminium water branches. Apparently, Ian has years of experience with powder coating (is there no end to his talents when it comes to improving our humble Austin 7?) and he told me that as well as providing an electrical insulator, it is the longest lasting, and most colour-durable quality of finishes available on virtually any type of metal; that powder coated surfaces are more resistant to chipping, scratching, fading, and wearing than other finishes; that it can withstand temperatures up to 550OC, so the Austin 7 engine environment would not be a problem. So we think that we have found the solution to stop the Austin 7 engine water jacket becoming blocked up with aluminium oxide, leading to overheating, which can result in further expensive repair bills.
