Magneto - repair - Richard Rowe

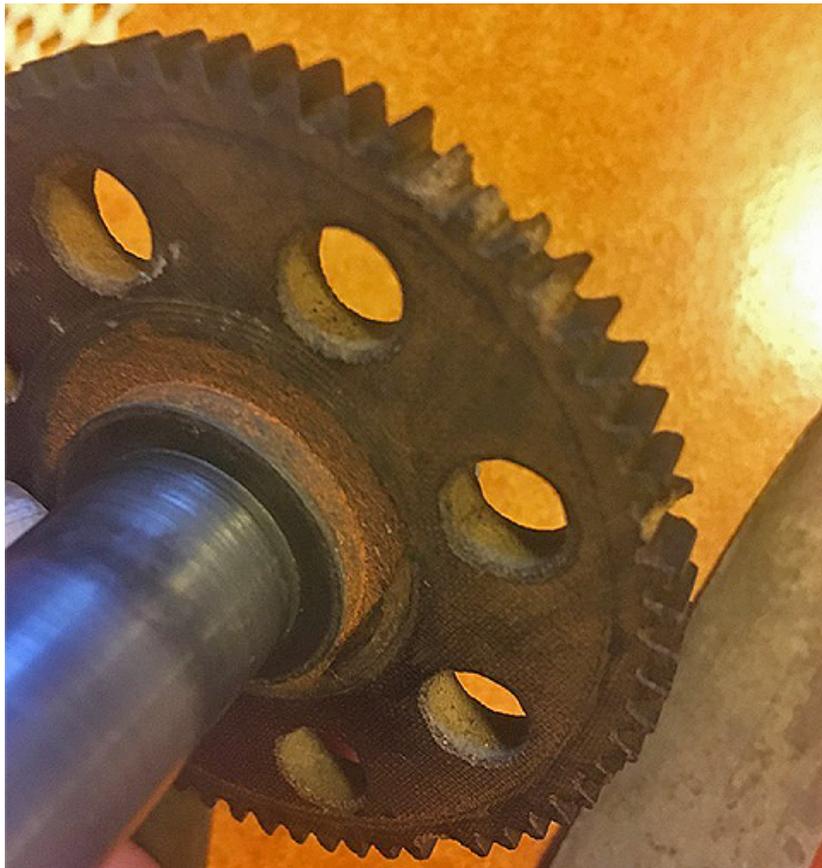
While trying to diagnose the reason for erratic behaviour of the magneto in my Chummy I found that the fibre gearwheel in the distributor had lost rather a lot of teeth.

This was a progressive failure as one tooth must have broken off and stuck in the smaller steel gear on the armature which then damaged the opposite teeth as the larger gear rotated.

Lost teeth

Not having a new gear or the ability to cut a new one (I did inherit a small lathe but not the skill to go with it) I decided to perform a dental repair by moulding new teeth in place.

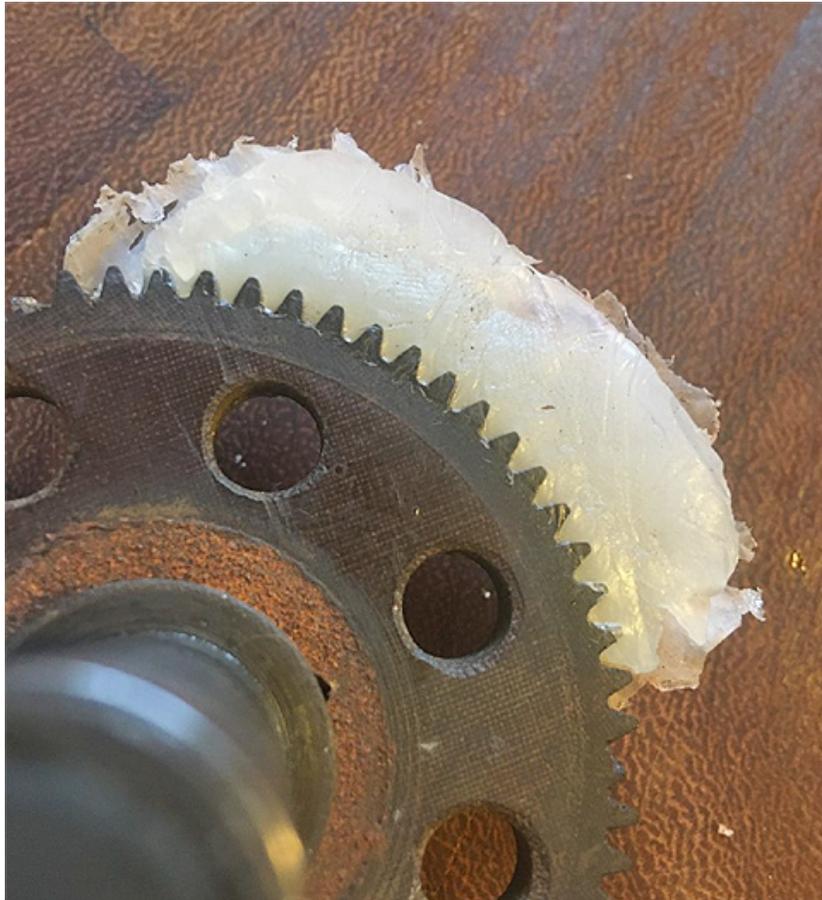
Making mould from good teeth

Rather than use the disgusting tasting dental impression material I used silicone sealant as it was in stock. This was held against the remaining good teeth on the gearwheel.

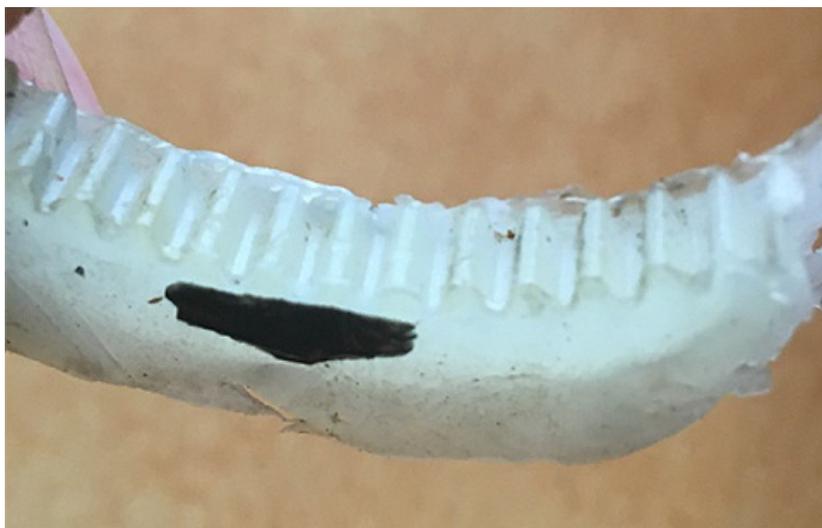
Silicone mould

After applying JB weld epoxy to the gappy teeth the silicone mould was used to form the new teeth. This was repeated at all 4 gaps around the gear.

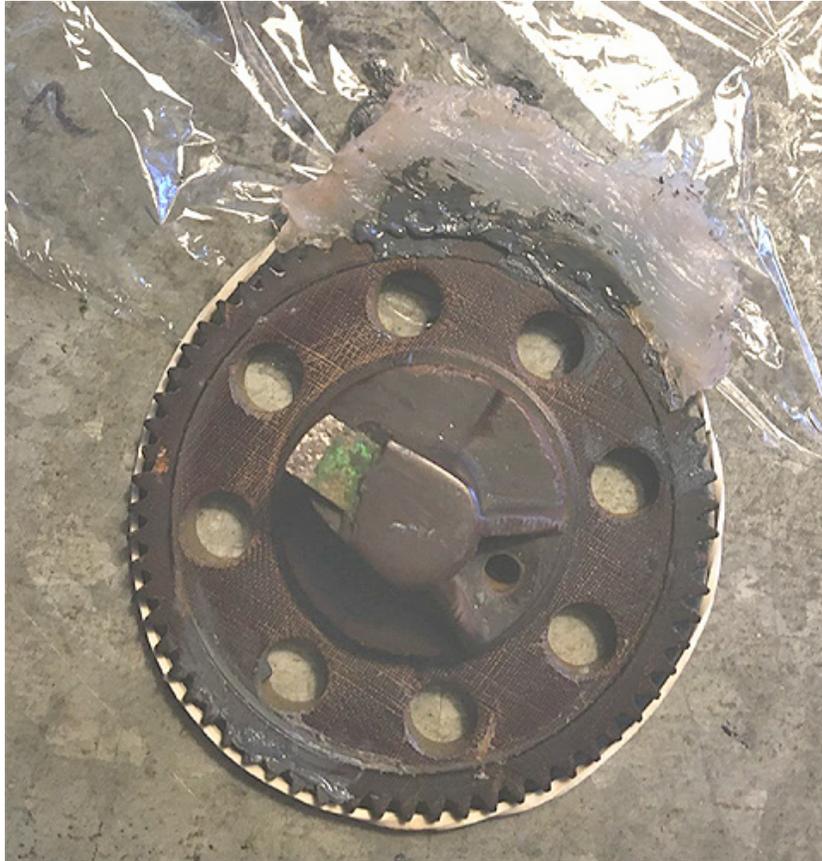
Moulding new teeth

The excess was trimmed off and the new teeth tidied with a fine file.

The mag was bench tested at 3,000 rpm and replaced in the car. All running well at the moment, will have to see how it lasts so now always carrying a towrope and AA membership card.

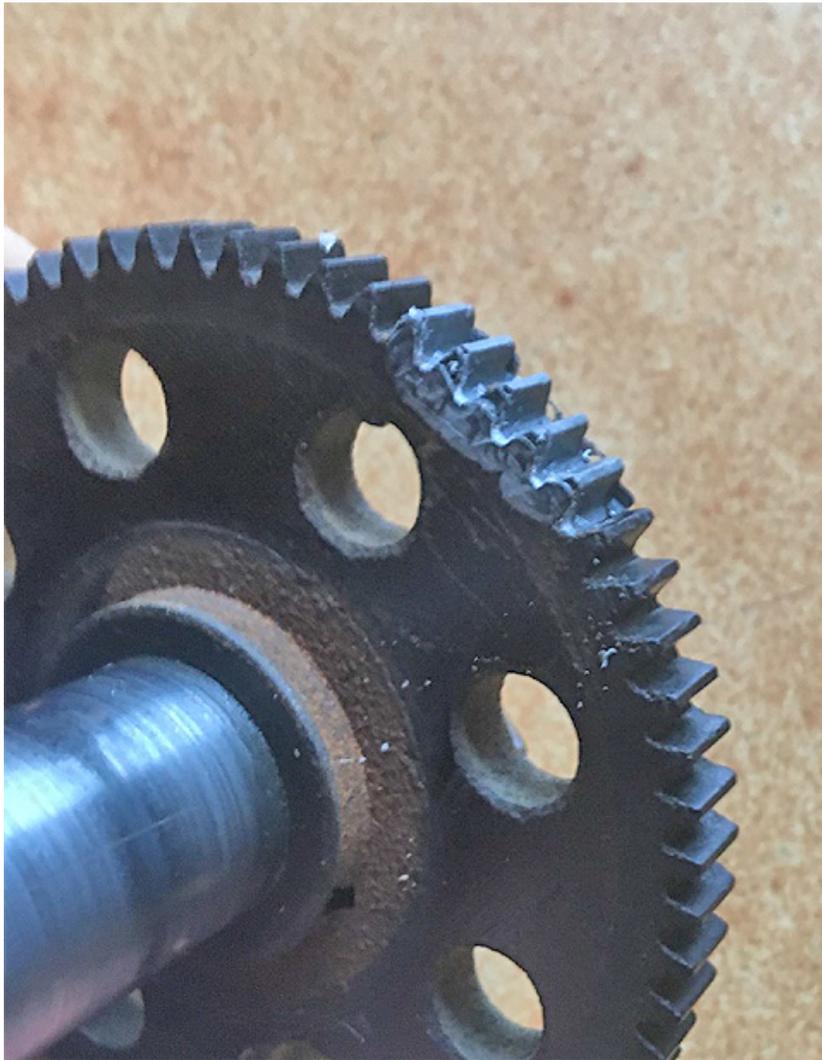
New teeth before tidying

Please see over for image of new teeth before tidying
