Spring Pin Removal - Ian Moorcraft

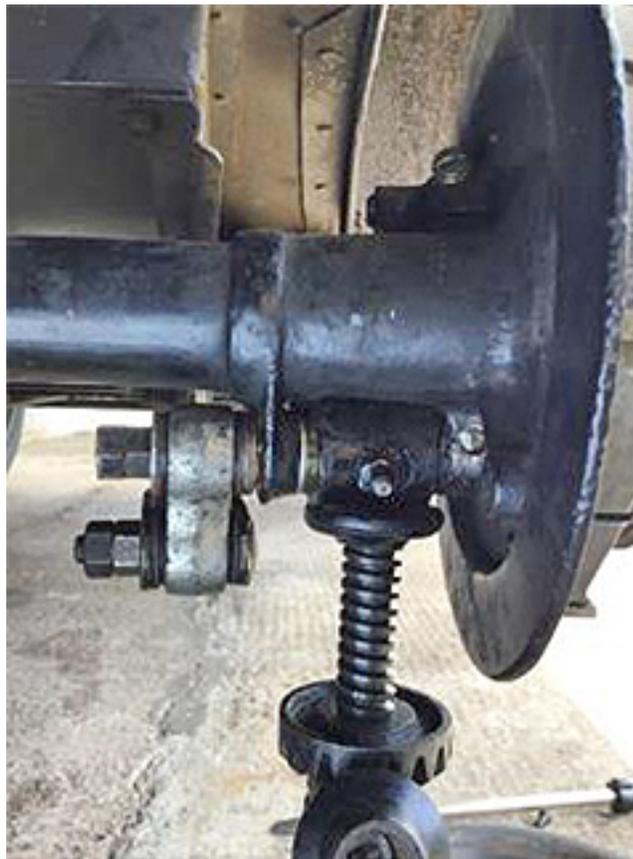
image 1

I left that job for another day giving everything a while to settle down before taking a measurement and producing a packing washer to suit. As can be seen from the photo the shiny new washer 0.048 thick completes the job. (1)

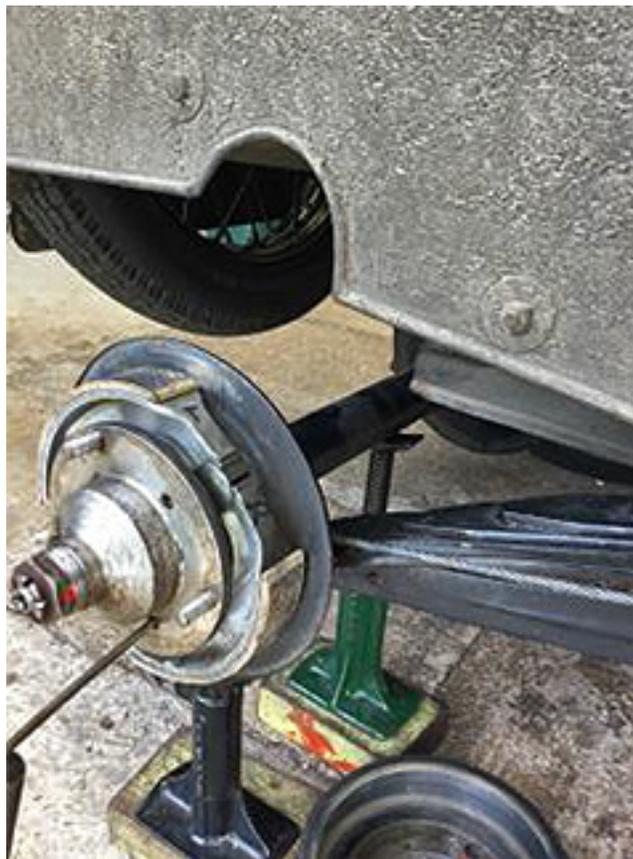
image 2

Start by jacking one side of the car, two Austin Seven jacks are ideal with one directly under the spring as shown and the other wound up lightly under the axle case leaving enough room for the axle pin to be removed.(2) I have found the job is much easier keeping the relationship between the axle and the chassis at normal running dimensions when removing and refitting the axle pins. If you jack up one side of the chassis with the spring hanging down it can make things really difficult.

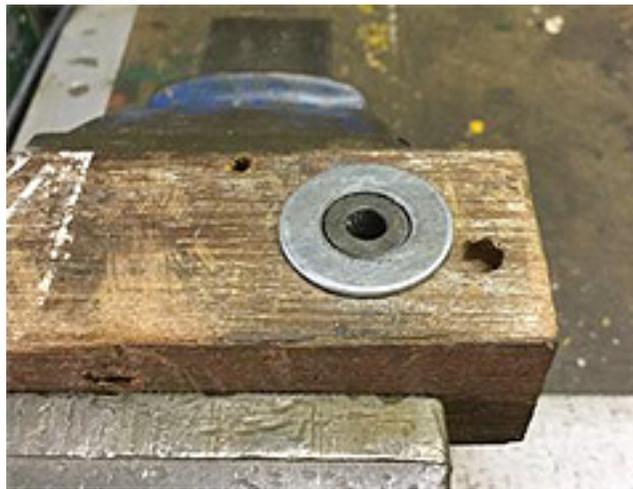
image 3

If the object of the operation is to fit washers to reduce side float, now is the time to measure the gap between the spring bushes and case lugs with feeler gauges. I would make the washers 0.008 less than the gap to help fitting. The way I file my washers to the correct thickness is to use a hardwood block with an old gudgeon pin tightly fitted into it, tap the pin just below the required finish size to hold the washer as you file,(3) use a file that is wider than the washer. The washer will spin as you file, but this seems to even out errors, the one in the photo was less than 0.002 thinner on one side after removing 0.012 so well within 'amateur mechanic' tolerances!

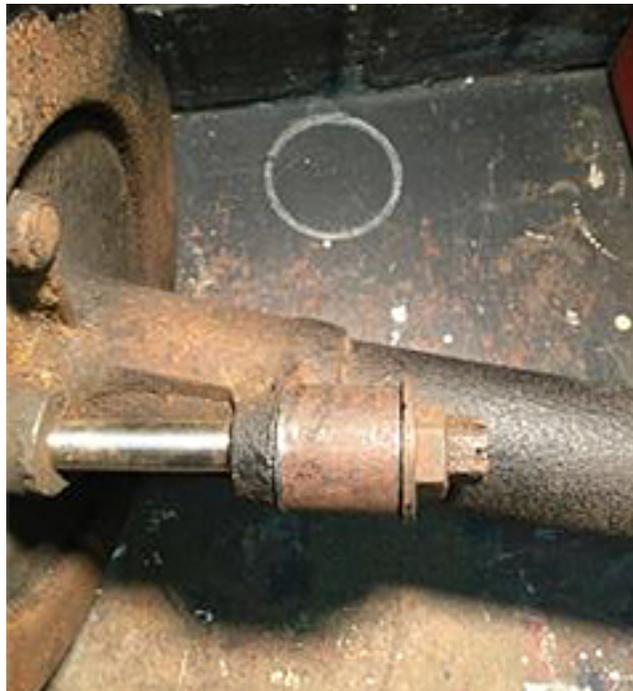
image 5

If all else fails you will need to gather odds and ends to make a puller, this is what I made mine from for this article: a piece of tube $1\frac{1}{8}$ " long just large enough to clear the flange on the pin, a nut to fit the thread on the pin ($\frac{3}{8}$ " BSF) two nuts large enough to go over the pin (cam shaft nuts I think) and a rear shock absorber dished washer.(5)

Remove the alloy link on the pin and assemble the tube followed by the dished washer and one of the large nuts. Do up the $\frac{3}{8}$ " nut as far as it will go, remove

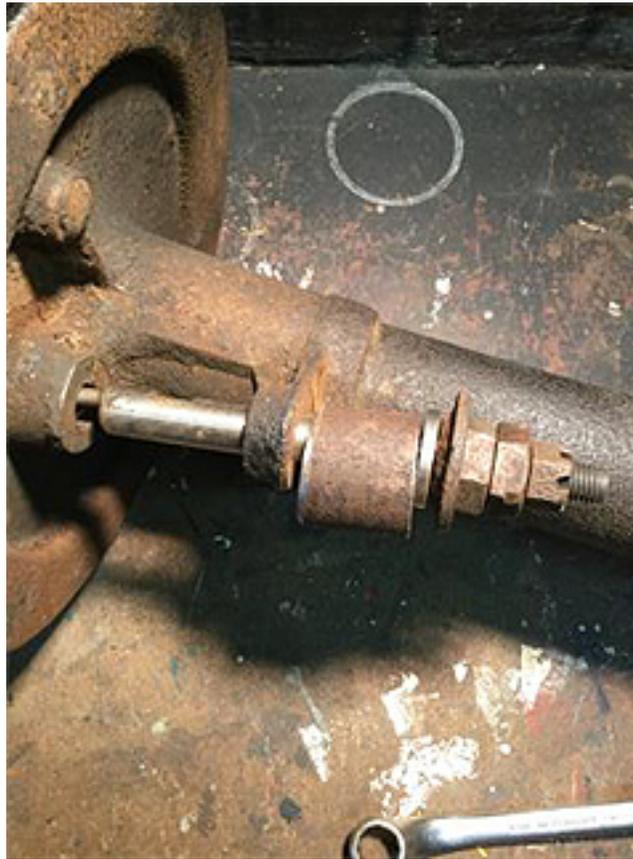
image 6

and put on the second large nut, by the time you wind the nut down as far as it will go this time the pin will be free from the back plate. (6) Use the $\frac{3}{16}$ " rod again to remove the pin completely .

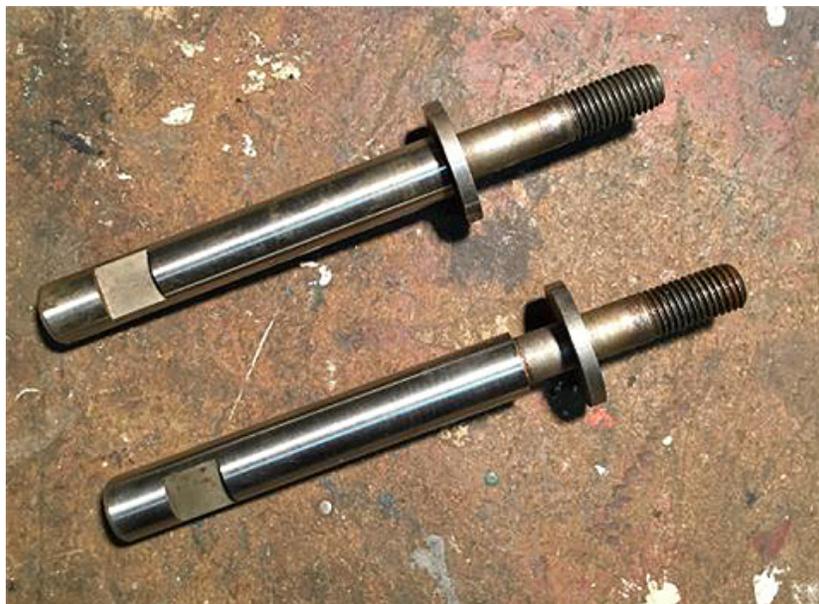
Tidying up after writing the above article, I noticed what appeared to be a slight defect in the new pin used in the photos showing the removal with the puller.

Close examination of the area where the flange diameter reduces to the pin diameter, and using an engineer's magnifying glass I was surprised to see that it appeared that the flange was in fact a thick washer!

Resting the flange on the vice jaws, and a slight tap with a hammer revealed all, as seen in the photo.

Obviously much cheaper to produce with an interference fitted separate flange than the original method of machining in one piece from a larger diameter bar.

Could this be one of the reasons why some have problems getting the cotters to fit? You possibly wouldn't notice the pin sliding along the flange as you taped it in. It would only need the pin itself to go $\frac{1}{8}$ " too far into the backplate to give problems fitting the cotter. If the hubs and brake shoes were still in place you could spend a lot of time and a few choice words before the penny dropped.

If this is how all spring pins are made now (they may not be of course), or just in case the ones you are fitting are the same, I would suggest you only ever use a piece of tube or old box spanner resting on the flange to tap in modern pins, rather than a nut on the thread as was the way with original style pins.

Another important thing missing on these pins was the slot along the threaded portion for the 'keyed' shock absorber flat washers. Without these static washers, even with the standard lock nuts a 'plain' flat washer and fibre washers the nuts could come loose with the radial movement of the compressed rubber link bushes.
