Tappet Cover Gasket - Ian Moorcraft

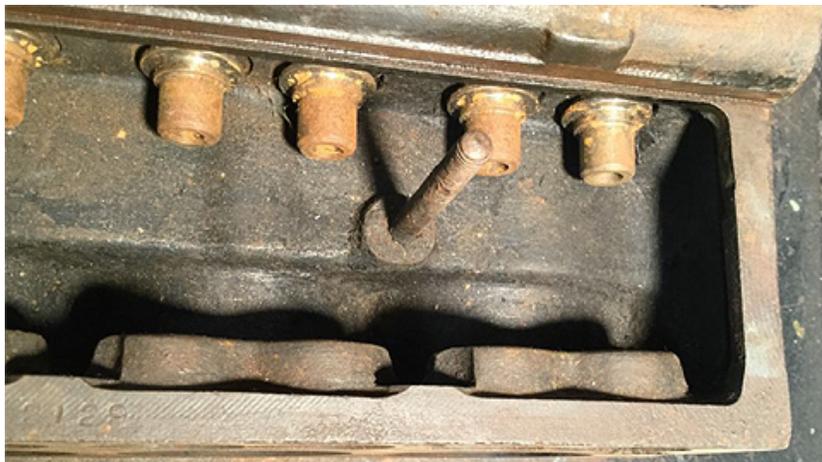
On these early blocks the land at the top of the block is so minimal that a good seal is difficult to achieve. It's hard to see why the top land wasn't designed of similar depth to the sides and bottom, this can cause oil leaks and more fumes than is considered normal.

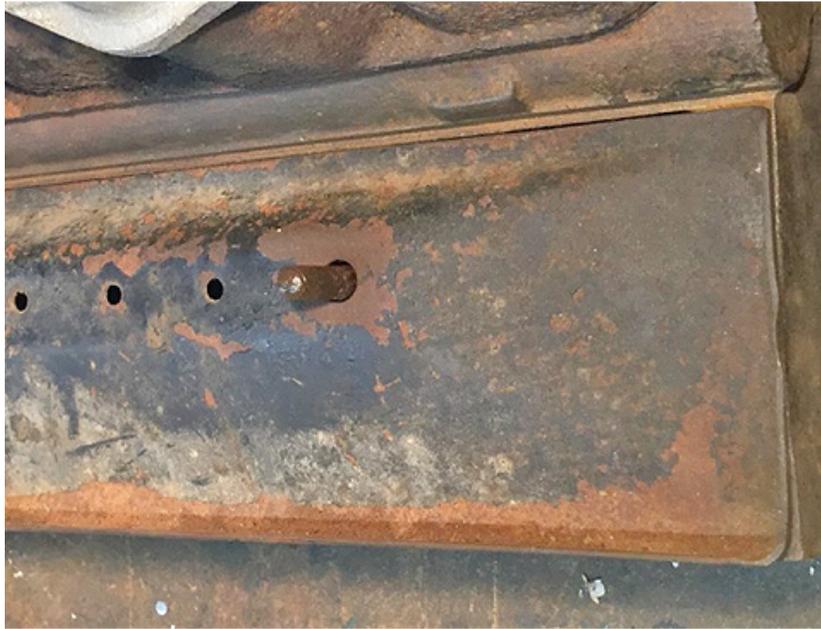
You can see in the photo below, a standard cover fitted without the gasket and when lifted up as far as the holes will allow, there is actually an open gap into the valve chest along the top.

You normally find that after a while in service the top of the cork gasket expands in the heat. It then slips out from under the cover and forms a pocket for the oil to collect between the cover and the gasket putting even more pressure on the bottom joint to hold oil.

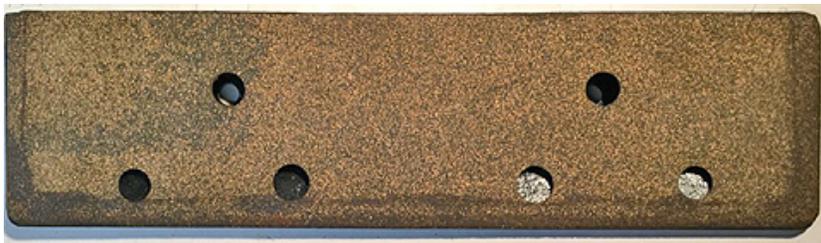
Check your cover for fit, if its like this one file the fixing holes at the bottom to allow the cover to be pulled up tight under the block. I always stick just the top of the gasket to the top of the tappet cover with Evo-stik impact adhesive to keep it in place. I also punch two extra holes along the bottom of the gasket for extra drainage.

I have never had a gasket slip out since the top was stuck down, so worth thinking about the next time you change the gasket.
