Water branch repair - by Colin Danks

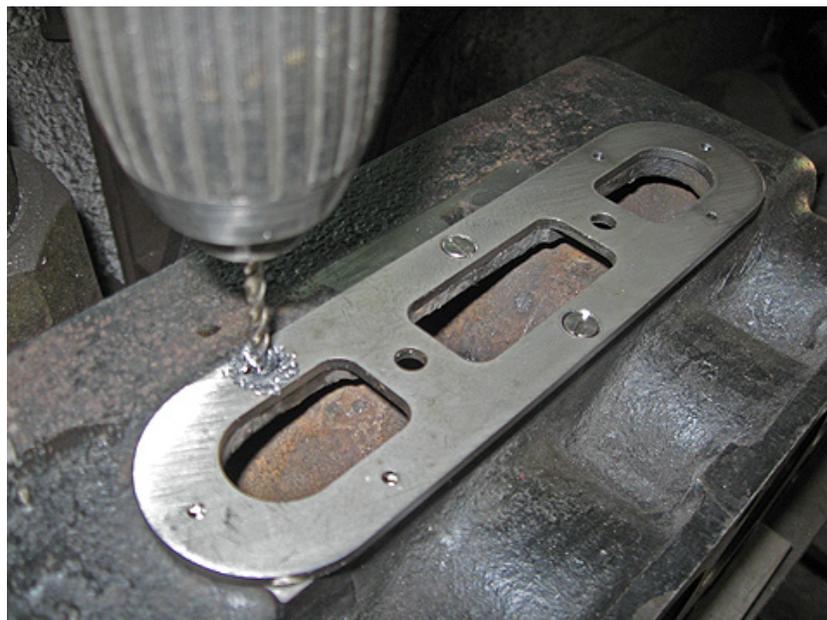
The repair plate comes in laser cut form with 10 pilot holes drilled (2 for the water branch studs and 8 for fixing the plate).

My method of fixing was to use 8 x M4 x 6mm countersunk cap head set screws to fix the plate to the block. This involved drilling out and countersinking the pilot holes.

Next step was to find two 5/16 BSF nuts and silver solder them to the back of the plate. I then used the nut as a tap guide to extend the thread through the plate. Hey presto, the studs can be screwed in. My preference was for stainless steel so no rusting problems (I hope).

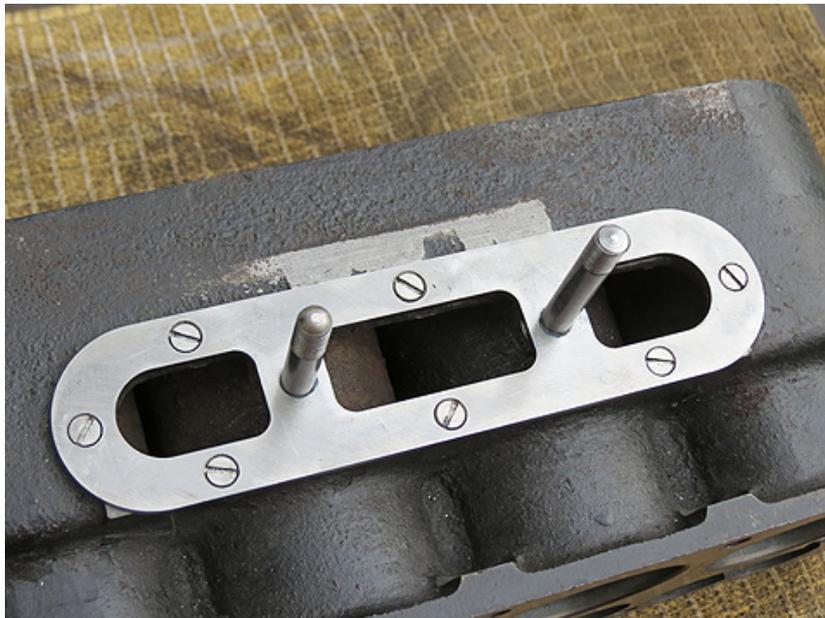
The final step was to mill (or hacksaw) the remains of the fixing points out of the block and to drill and tap 8 fixing holes using the repair plate as a template.

For simplicity I used silicone sealant and a thread lock to ensure it does not become incontinent when filled with water. The block was then pressure checked with boiling water.

Result: the saviour of a very ropey, but original block from my shared 1930 Fabric Saloon. "Want not, waste not", as my Grandma says.
