### Dynamo housings - Endangered Species? - by Ian Moorcraft

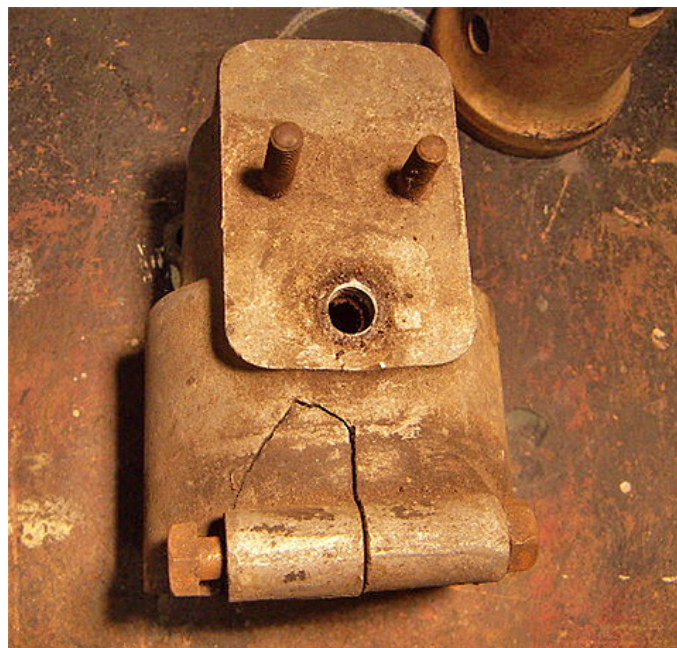
Pic A

If we look at the magneto housings first, the damage is always the same, being cracked from the end of the slot **Pic A** - not always as bad as this, but if you find 10 of these, nine will have some cracking here. So why is it? Well, people remove the obvious bolt and nut then find they cannot remove the dynamo and wrongly assume it is tight in the casing, so out comes the screwdriver to jam in the slot to force the case apart, and goodbye to another dynamo housing.

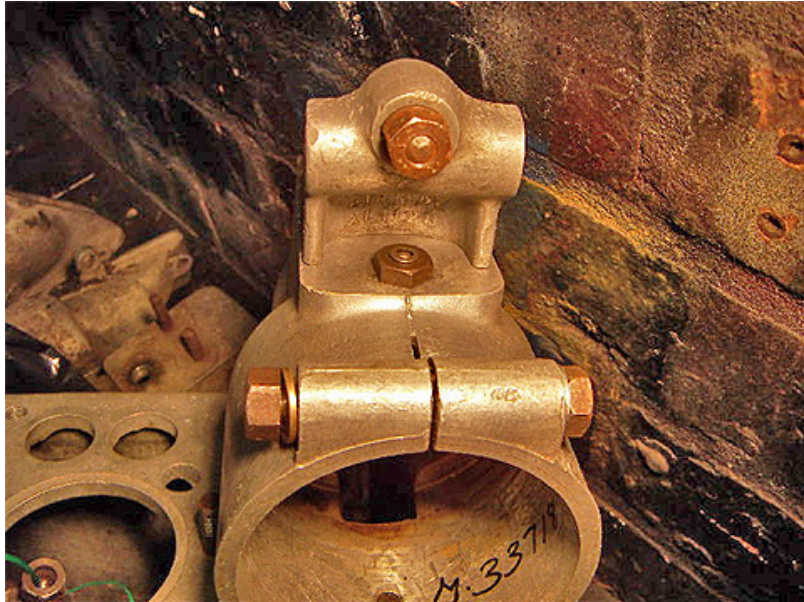
Pic B

Looking at **Pic B** the Bennett Oiler that sits under the small fan bracket doubles up as a locating spigot for the dynamo revealed in **Pic C**; if you don't remove this you cannot remove the dynamo.

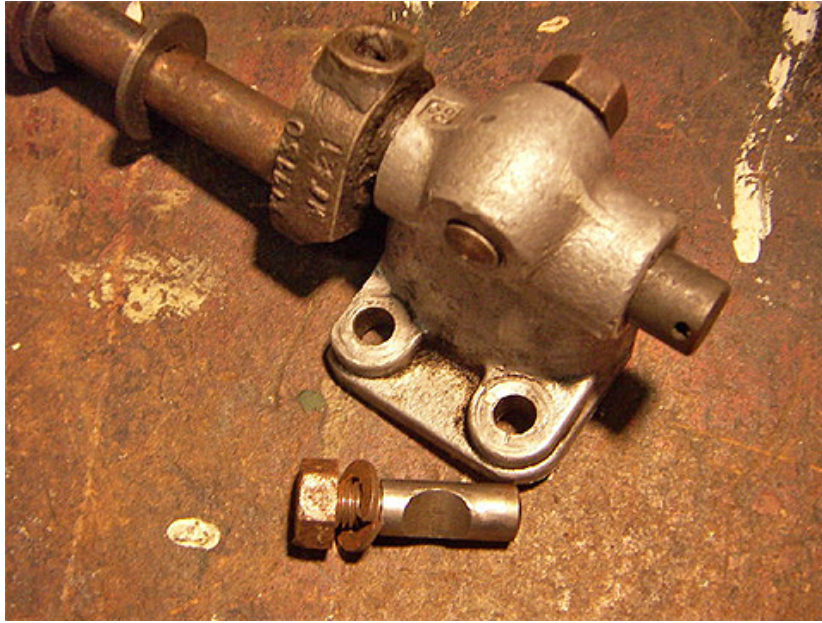
Pic D

Moving on to the coil engine dynamo housing, four times as many of these were made as were the magneto ones, but of course probably four times as many coil cars that need them still exist today. The damage on these is almost universal; if it's broken it will be the top of the casting where the fan spindle fits and this is simply because people have not realised the cotter\* that holds the spindle in place is not a bicycle type with a flat, but half moon ground in the cotter, it is the same type cotter as the magneto cars shown in **Pic D**. Trying to hammer it out breaks the top off the casting (you can also break the casting on both types by over tightening with the dreaded socket set). All that is needed to remove the fan spindle is to loosen the nut and give the cotter pin one sharp tap and then revolve the spindle back and forth pulling outwards as you do so.

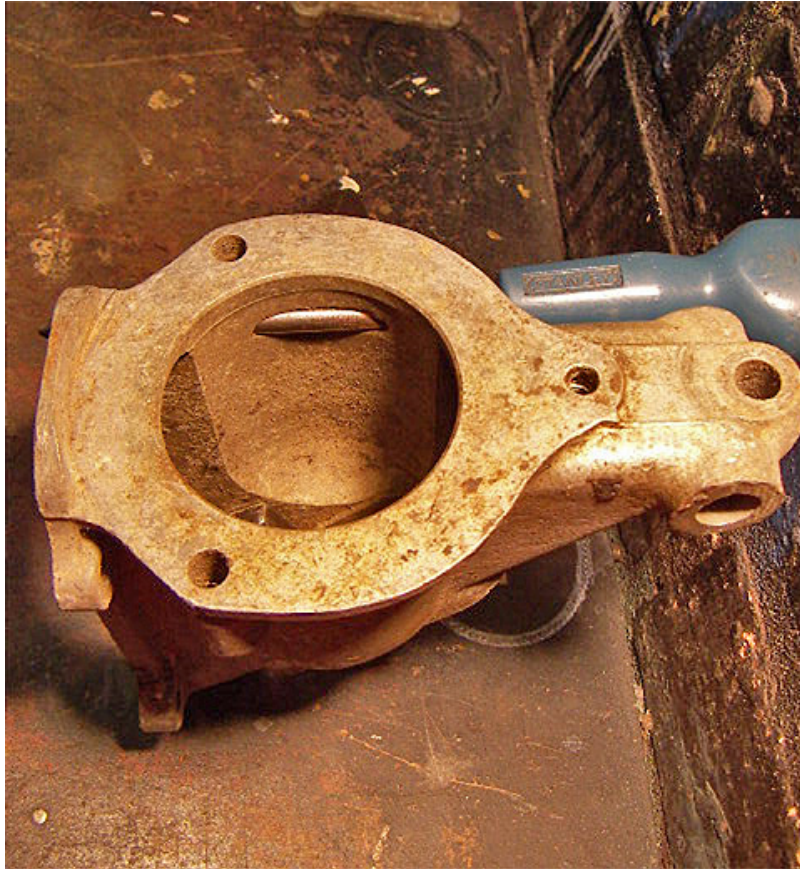
Pic E

Removing the dynamo on coil cars can sometimes be a problem; the three bolts are out but the dynamo will feel loose but will not come out, so some take off the little tin cover on the other side of the housing (what is it for?) and try to lever or hit the dynamo out with a hammer without success. Looking at **Pic E** shows how the long housing fixing bolt breaks into the space for the dynamo case and **Pic F** shows the corresponding half of the slot ground into the dynamo bearing housing, effectively locking the dynamo into place. If you have this problem you must remove the long housing bolt as well as the three bolts on the dynamo. You

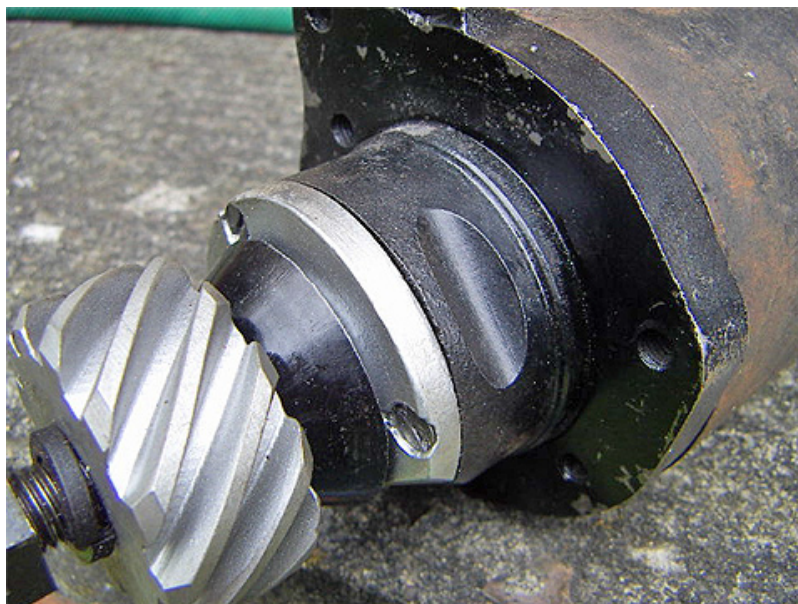
Pic F

If you are building up a spare dynamo for a 1931/39 car, avoid the type in **Pic F**. Removing the long bolt every time is a drag, and it will eventually strip the thread in the crankcase and you will end up with a difficult job on your hands to rectify the thread.

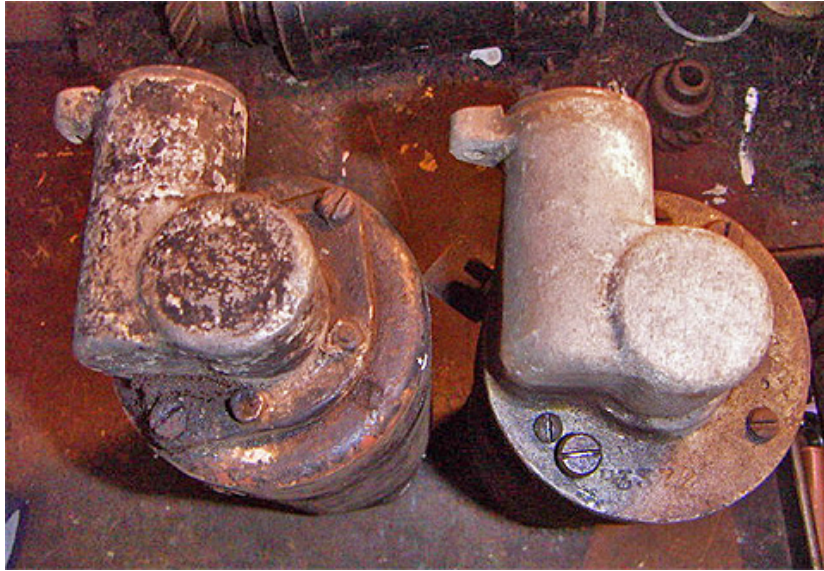
Pic G

You will not have this problem with the first coil CAV dynamos. **Pic G** shows the first type introduced in late 1928 on the left with a two piece steel and aluminium end cap and the second type in 1929 with a one piece aluminium end cap; the third type late 1930/31 looks exactly the same but the one piece end cap is steel. All of these are flat at the gear end and give no problems see **Pic H**.
