### Spring Pin Removal - Ian Moorcraft

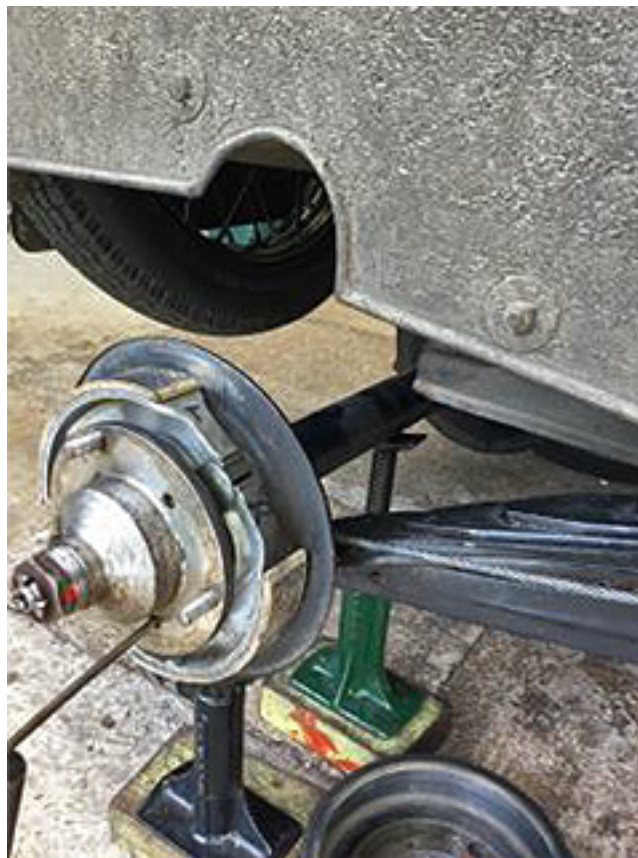
image 2

Start by jacking one side of the car, two Austin Seven jacks are ideal with one directly under the spring as shown and the other wound up lightly under the axle case leaving enough room for the axle pin to be removed.(2) Also use blocks or axle stand under the rear cross member. I have found the job is much easier keeping the relationship between the axle and the chassis at normal running dimensions when removing and refitting the axle pins. If you jack up one side of the chassis with the spring hanging down it can make things really difficult.

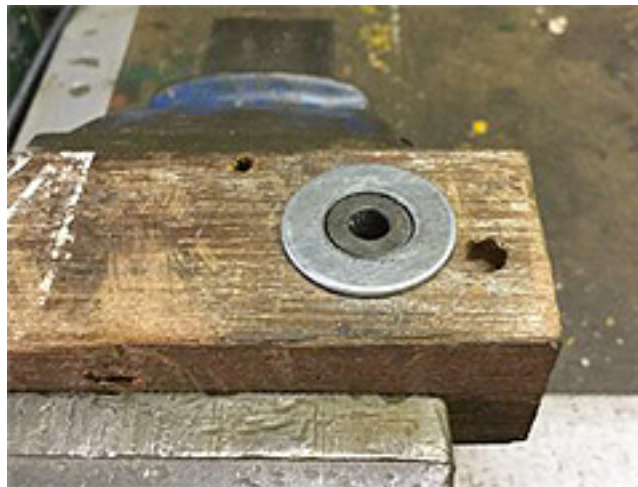
image 3

If the object of the operation is to fit washers to reduce side float, now is the time to measure the gap between the spring bushes and case lugs with feeler gauges. I would make the washers 0.008 less than the gap to help fitting. The way I file my washers to the correct thickness is to use a hardwood block with an old gudgeon pin tightly fitted into it, tap the pin just below the required finish size to hold the washer as you file,(3) use a file that is wider than the washer. The washer will spin as you file, but this seems to even out errors, the one in the photo was less than 0.002 thinner on one side after removing 0.012 so well within 'amateur mechanic' tolerances!

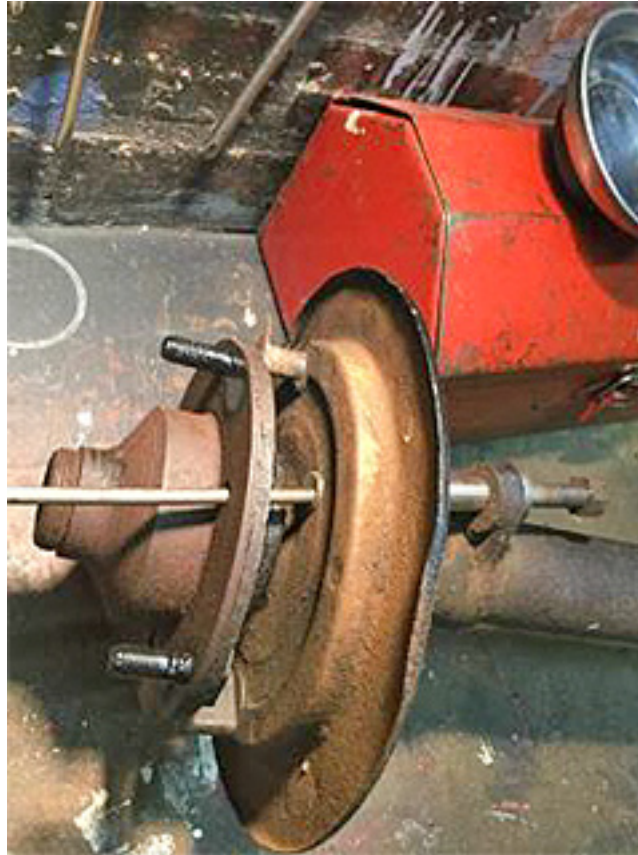
image 4

Now we tackle removing the pin, you will note that the shock absorber alloy link is still fitted on the pin, leave it on as it will help with something to grip for rotating the pin when realigning the cotter slot later. If the pins have been removed at some time in the recent past it's worth trying to punch them out. Remove the brake drum, using a piece of  $\frac{3}{16}$ " rod you can push it through one of the holes vacated by the drum screws.(4) If you hold the rod against the back plate while rotating the hub you should be able to "feel" the end of the pin. If you need to buy a piece of rod, get stainless as it's much stronger. The photo of my car shows the method, and also here using a spare axle showing more clearly what you are actually doing.

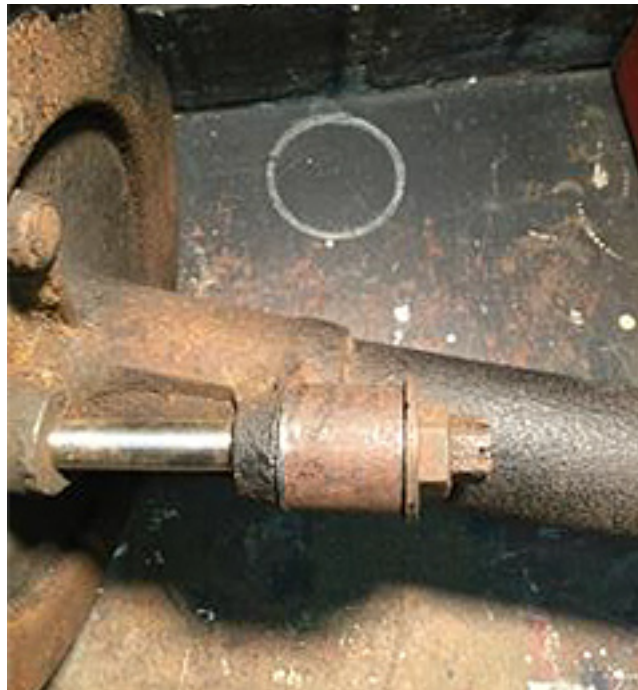
image 5

If all else fails you will need to gather odds and ends to make a puller, this is what I made mine from for this article: a piece of tube  $1\frac{1}{8}$ " long just large enough to clear the flange on the pin, a nut to fit the thread on the pin ( $\frac{3}{8}$ " BSF) two nuts large enough to go over the pin (cam shaft nuts I think) and a rear shock absorber dished washer.(5)

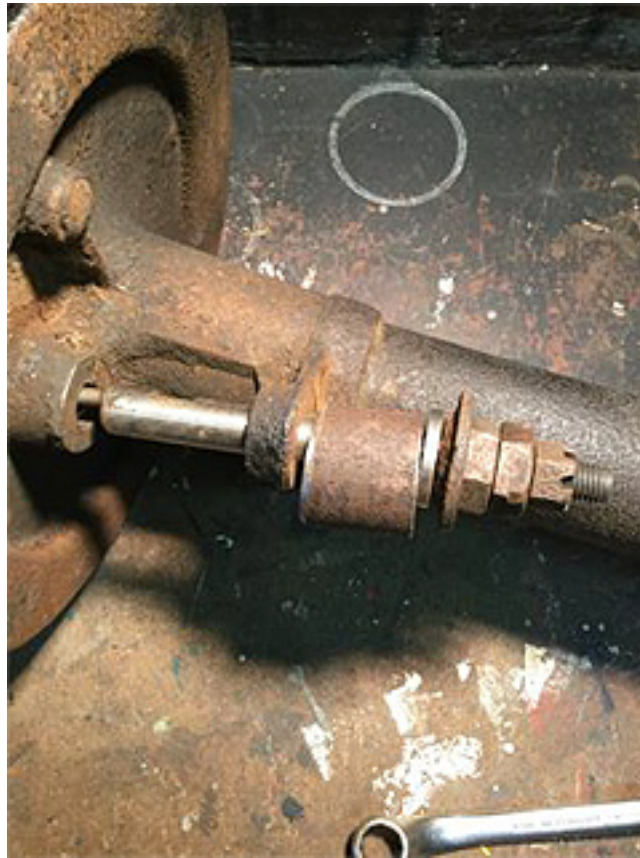
image 6

Remove the alloy link on the pin and assemble the tube followed by the dished washer and one of the large nuts. Do up the  $\frac{3}{8}$ " nut as far as it will go, remove

and put on the second large nut, by the time you wind the nut down as far as it will go this time the pin will be free from the back plate. (6) Use the  $\frac{3}{16}$ " rod again to remove the pin completely .

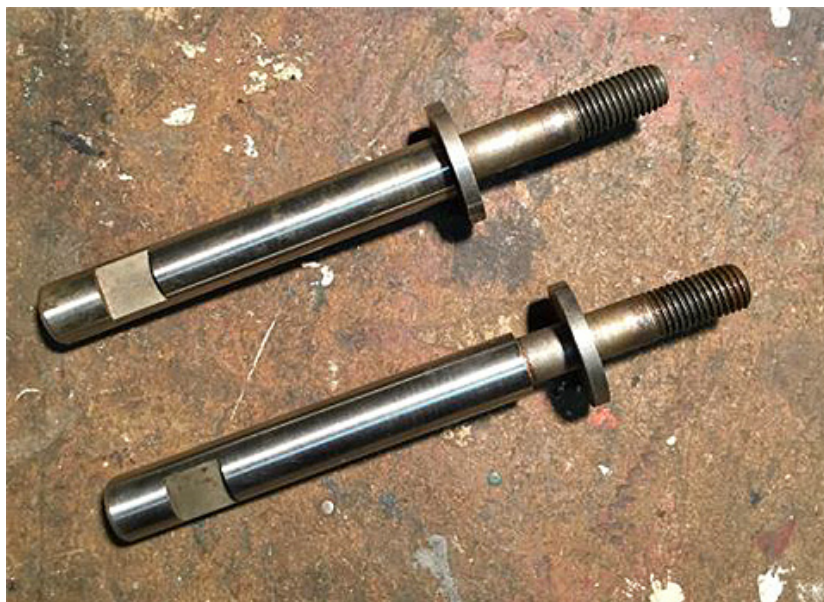
Tidying up after writing the above article, I noticed what appeared to be a slight defect in the new pin used in the photos showing the removal with the puller.

Close examination of the area where the flange diameter reduces to the pin diameter, and using an engineer's magnifying glass I was surprised to see that it appeared that the flange was in fact a thick washer!

Resting the flange on the vice jaws, and a slight tap with a hammer revealed all, as seen in the photo.

Obviously much cheaper to produce with an interference fitted separate flange than the original method of machining in one piece from a larger diameter bar.

Could this be one of the reasons why some have problems getting the cotters to fit? You possibly wouldn't notice the pin sliding along the flange as you taped it in. It would only need the pin itself to go  $\frac{1}{8}$ " too far into the backplate to give problems fitting the cotter. If the hubs and brake shoes were still in place you could spend a lot of time and a few choice words before the penny dropped.

If this is how all spring pins are made now (they may not be of course), or just in case the ones you are fitting are the same, I would suggest you only ever use a piece of tube or old box spanner resting on the flange to tap in modern pins, rather than a nut on the thread as was the way with original style pins.
