Body - repair - rivets and splits - Steve Barker

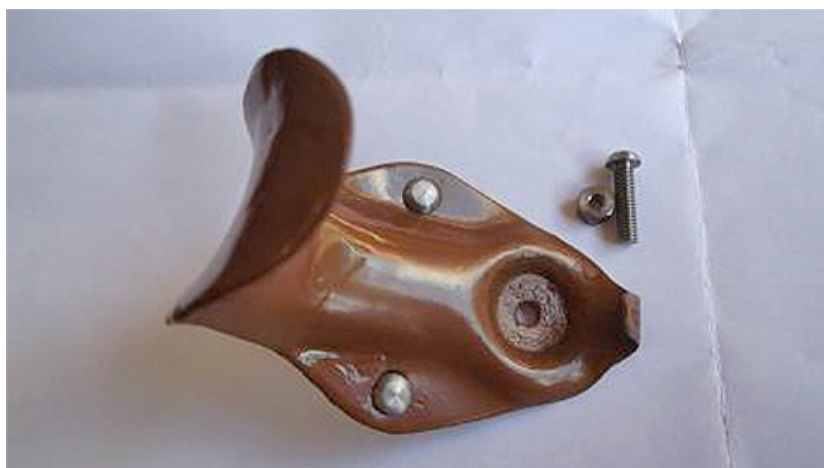
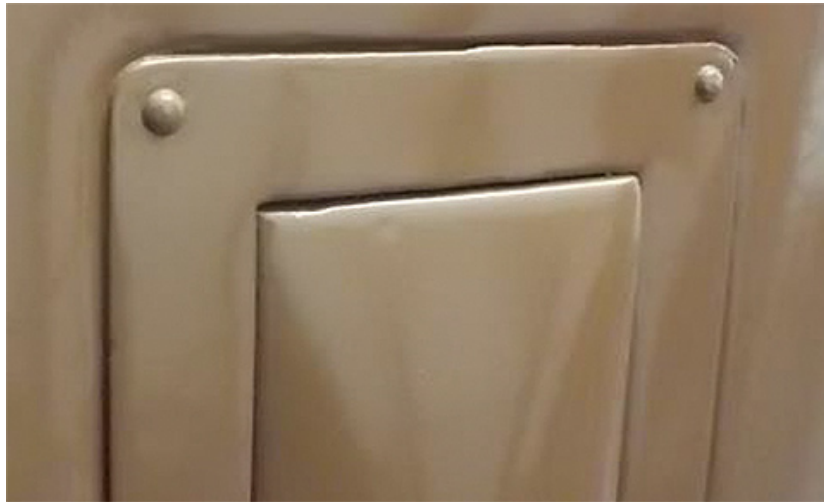
Having drilled out various rivets while stripping the RN Saloon body before painting, I needed to replace them. The easiest and tidiest way was to replace everything with appropriately sized BA bolts with no slot heads which are indistinguishable from the original rivets as photos 1 and 2 show. BA sizes to match original rivets are:

the bonnet handles - 5 BA; letterbox vents 4 BA; and one of the spare wheel carrier studs 2BA.

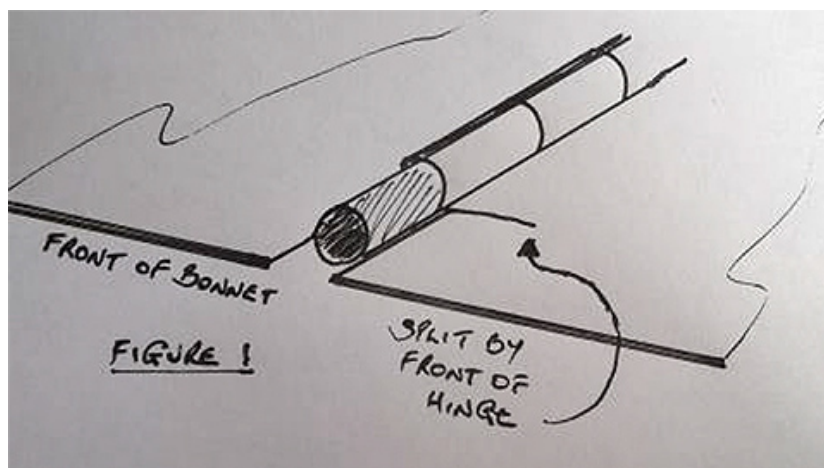
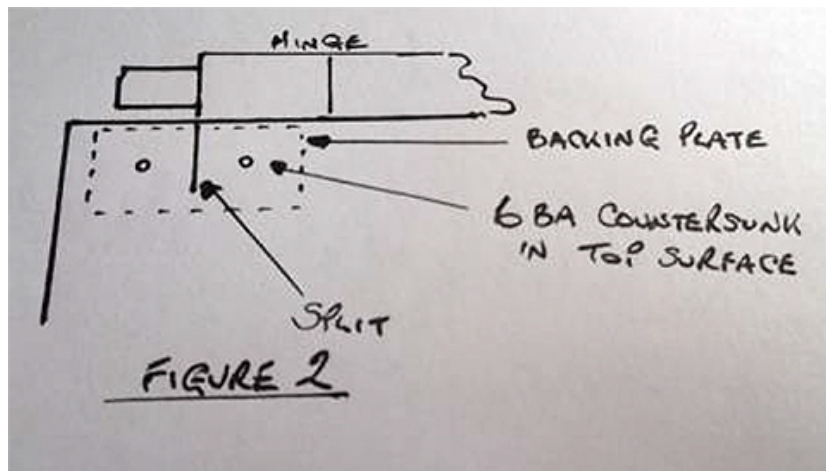
Figures 1 and 2 illustrate my technique for dealing with stress splits which are especially common on bonnets often near the vents and if not dealt with ruin the finish of the paintwork. I would never attempt a weld of any kind because of the likelihood of distortion and rely on the glue and screw method by using JB Weld an American 2 pack metal adhesive but Araldite or similar would probably suit as long as it doesn't react with the paint finish. For the screws I use 6BA countersunk which, if carefully fitted on the finished side of the work, require very minimal filling and finishing.
